S E R V I C E N O T E

8711B Network Analyzer**Serial Numbers:**

Failure to reach low end frequency on the 8711B and 8712B**To Be Performed By:** Agilent-Qualified Personnel or Customer**Duplicate Service Notes:** 8711B-01, 8712B-01**Parts Required:**

DATE: June 1996

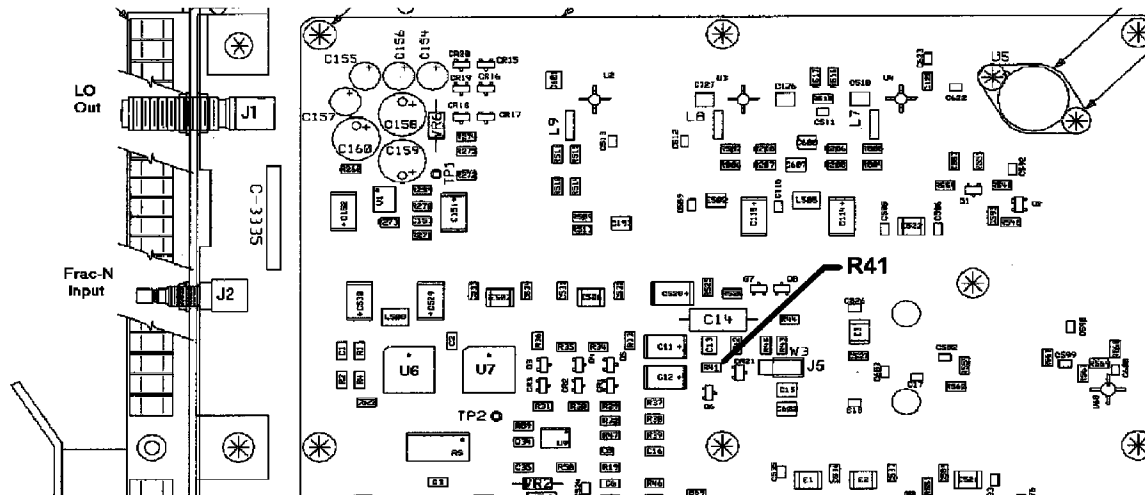
Several 8711B and 8712B customers have reported that they have improper transmission or reflection response somewhere below 50 MHz. The failure almost always arises when in the “dither” sweep mode. It may also appear in the “spur-avoid” mode. In rare cases has it been seen in normal sweep mode. Analysis of this failure has determined that a recent change to a circuit design has prevented the VCO from obtaining the required low end frequency of 300 kHz. Depending upon the individual VCO, the minimum frequency obtainable could be as high as 50 MHz.

To solve this problem, a simple resistor change must be made to the A4 Source board (p/n 08712-60004). Please note that this resistor is a surface mount component, located under a metal shield, so extra caution will need to be exercised. Because these resistors are both fragile and inexpensive, it is recommended that several extra resistors be ordered. To implement this modification, change resistor A4R41 from its current value of 287 ohms (see note below) to 162 ohms (P/N 0699-1420). See figure for the exact location.

Many of these instruments may have an existing resistor value of 121 ohms instead of 287 ohms. This may cause a similar problem. In either case, replace the existing value with the 162 ohm resistor.

Unsolder A4R41 and replace it with the 162 ohm resistor. Use extreme caution since this is a surface mount component. Although probably not necessary, it is generally a good idea to redo adjustments #104 through #109. If the problem existed even when the analyzer was not in dither mode, then performing these adjustments is definitely required.

After the resistor has been replaced, permanently mark the front of the A4 board shield with "Modified per 8711B-01." It may also be helpful to mark the rear panel similarly.
