S E R V I C E N O T E

87510A Gain-Phase Analyzer

Modification to fix unexpected spurious problem.

DATE: 15 April 1995

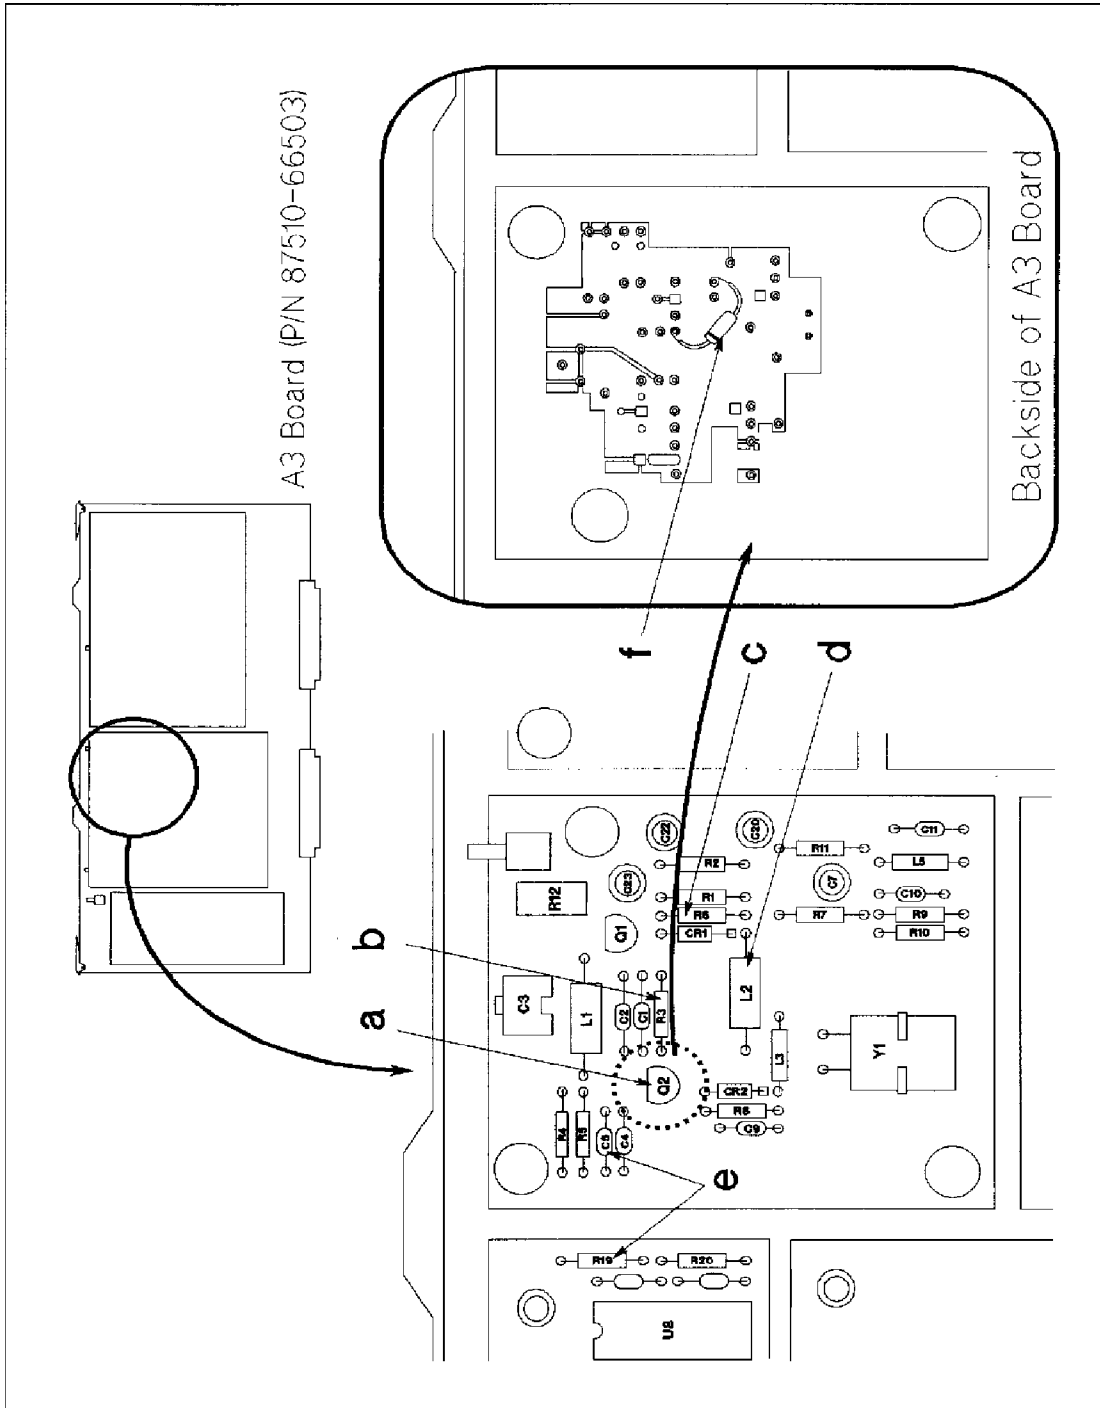
Figure 1. A3 Board Modification

The 87510A may show the unexpected spurious response due to the parasitic oscillation of the source signal.

This is caused by the breakdown of A3Q2 transistor. This symptom can be confirmed using the following procedures:

1. Turn the 87510A off. Remove the top cover and the shield plate.
2. Remove the A3 board.
3. Modify the A3 board with referring Figure 1:
 - a. Replace the A3Q2 transistor (P/N 1854-1073) with the new one.
 - b. Replace the R3 resistor. 464 ohm --> 1 kohm (P/N 0757-0280)
 - c. Replace the R6 resistor. 464 ohm --> 316 ohm (P/N 0698-3444)
 - d. Replace the L2 inductor. 680 nH --> 470 nH (P/N 9100-3548)
 - e. Replace the location of C5 (0.01 uF, P/N 0160-4832) and R19 (215 ohm, P/N 0698-3441).
4. Perform the following adjustments:
 - 100 MHz VCXO Frequency
 - 1st IF Offset Osc Frequency
 - Fractional N Pretune CC
5. Reinstall the A3 board.
