S E R V I C E N O T E

8753D Network Analyzer

Serial Numbers: 0000A00000 / 3410A06400

Power Supply Modification when installing Firmware Rev. 6.14 on older 8753Ds**Parts Required:**

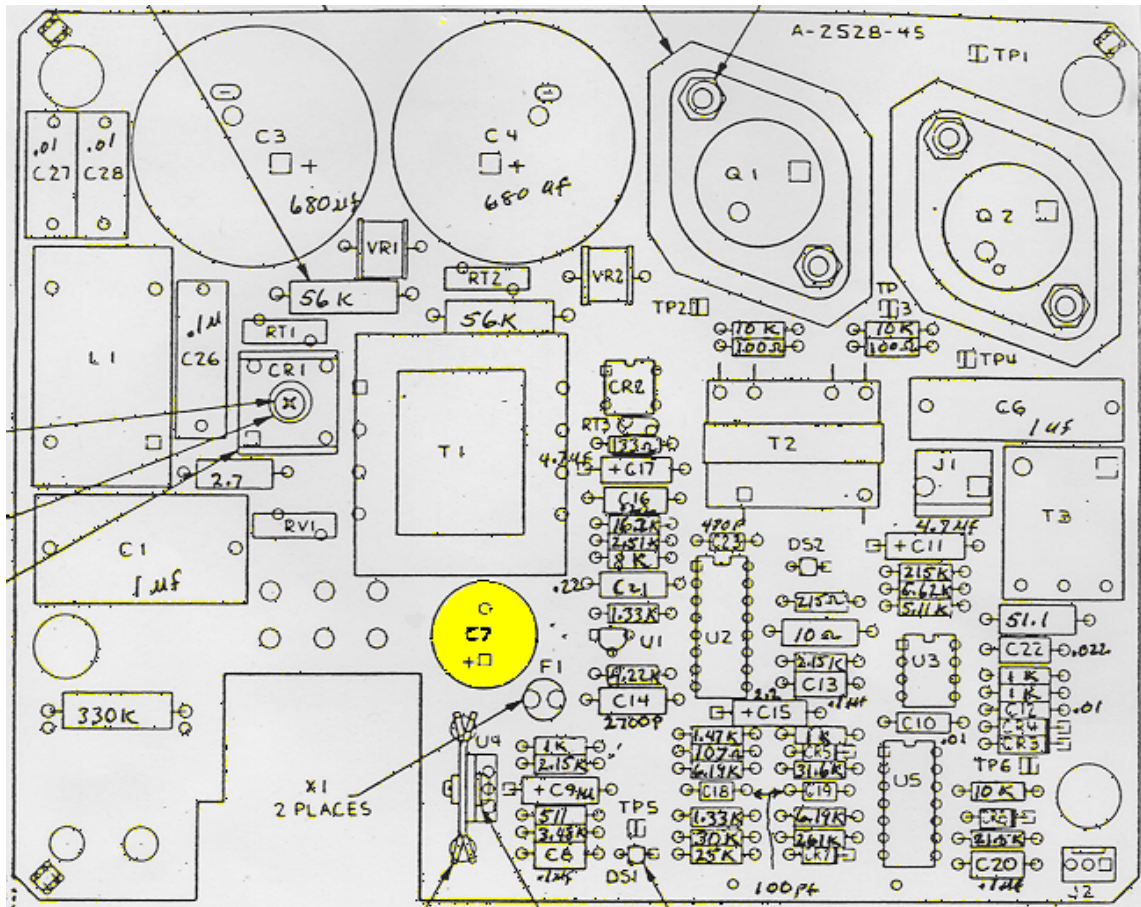
Preregulator Drawing

When upgrading to firmware revision 6.14, 8753D units with serial numbers in the above range may demonstrate CRT display problems related to the power down routine of the CPU. Typical symptoms include a blank display, unusual colors or lack of colors after the power has been cycled twice following the insertion of the EPROMs.

Replace capacitor C7 in the power supply preregulator with the part listed above or equivalent. For complete detailed instructions on how to perform this modification, see the installation note supplied in the firmware upgrade kit.
