E5070A-03

S E R V I C E N O T E

E5070A ENA Series Network Analyzer, 300 kHz to 3 GHz

Handler I/O Port Malfunction Due to TTL-Low Level Threshold Voltage Anomaly

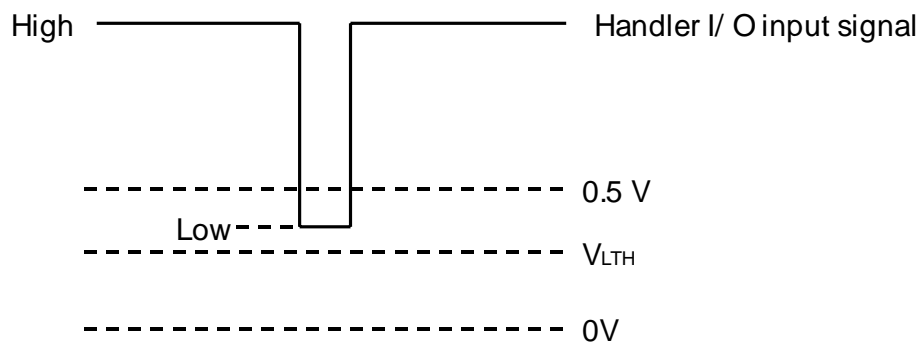
The 24-bit handler I/O of the E5070A units with the specified serial numbers may not function normally. Due to the possible threshold-voltage anomaly of TTL input circuit at either of the I/O pins 2, 18 and 22 through 29, the handler I/O port may ignore the “Low” state of control input signals. When the threshold voltage for TTL-Low level is too low (lower than 0.5 V), it is possible that control input signal does not cross the threshold voltage (V_{LTH}) though the “Low” level of the signal is within the recommended voltage range (0 V to 0.5 V). As a result, a handler interface error occurs. See Figure 1.

Figure 1. Threshold voltage anomaly

When the threshold voltage of the handler I/O (either of the I/O pins) is too low, replace the A23 Handler I/O board with new one (P/N E5070-61006).
