E5070A-05C

S E R V I C E N O T E

E5070A ENA Series Network Analyzer, 300 kHz to 3 GHz

When a measurement trace or output power shows troubles between 1.3 GHz and 2.1 GHz, or in full frequency range, replace A1 module with the latest one (E5071-6x571), and update E5070A Operating System at the same time.

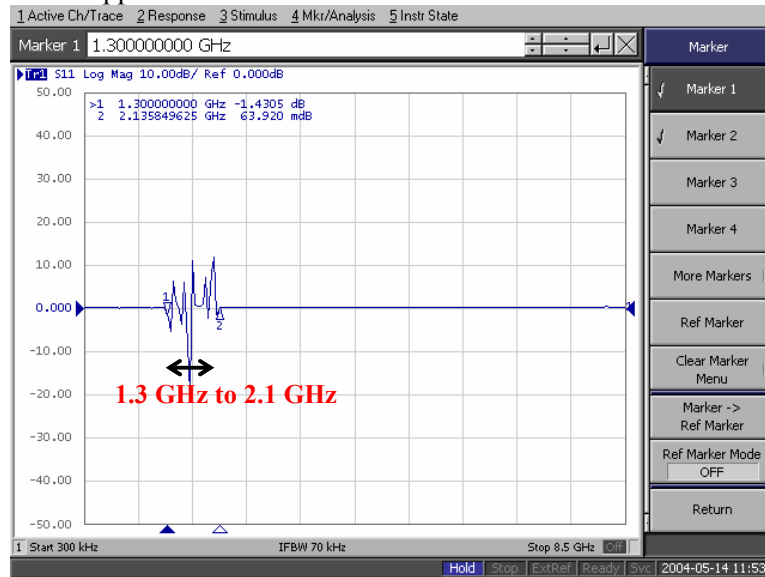
When the high-failure rate part has defective, the unit cannot output correct power level source or local signal, between 1.3 GHz and 2.1 GHz frequency range.

Above symptoms tend to appear after 30-minute heat run.

Figure 1. Trace shows noise around 1.3 GHz to 2.1 GHz at preset setting.

Update the E5070A operating system image referring to the service note E5070A-06B. Then, replace A1 module and perform the appropriate post repair procedures referring to the E5070A/E5071A service manual chapters 6 and 7.

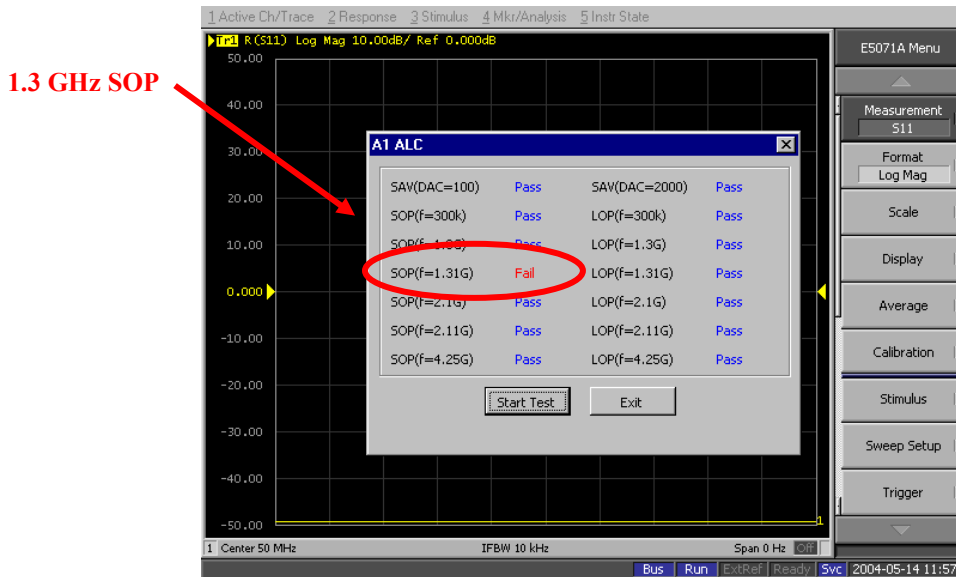
- The trace shows spike at 1.3 GHz or 2.1 GHz at the preset situation.
- The trace between 1.3 GHz to 2.1 GHz is more noisy than other frequency ranges.
- The power level of 1.3 GHz to 2.1 GHz is lower than other frequency ranges.
- Internal test of A1 ALC shows fail at SOP (f=1.3G) or LOP (f=1.3G) as Figure 2.

Figure 2. A1 ALC in Internal test has failure at SOP (f=1.3G) or LOP (f=1.3G)
