MODIFICATION RECOMMENDED –
CORRECTS MANUFACTURING OR DESIGN DEFECTS

E5070A-08

S E R V I C E N O T E

E5070A ENA Series Network Analyzer, 300 kHz to 3 GHz

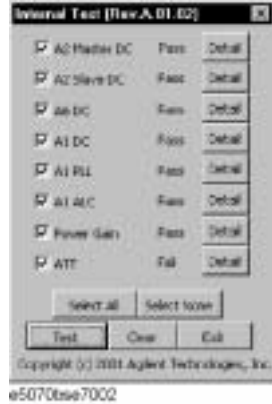
Internal Test dialog box (rev.A01.02 or earlier)

Internal Test is failed on Step Attenuator Test Group, due to the old attenuator reliability.

When the attenuator (33321-60059) is defective, replace with the new replacement attenuator (33321-60069, not 33321-60068) and replace A86 (E5070-66586) with revised one (E5070-65086). There is no need to upgrade firmware for this replacement.
