E5070B-01

S E R V I C E N O T E

E5070B ENA Series Network Analyzer, 300 kHz to 3 GHz

Handler I/O Port Malfunction Due to TTL-Low Level Threshold Voltage Anomaly

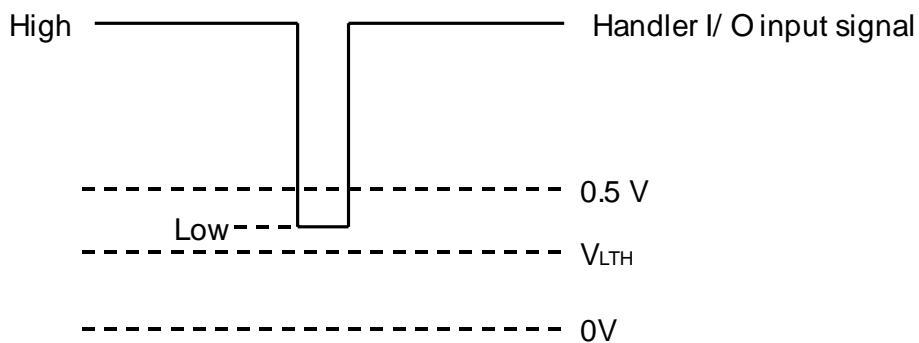
The 24-bit handler I/O of the E5070B units with the specified serial numbers may not function normally. Due to the possible threshold-voltage anomaly of TTL input circuit at either of the I/O pins 2, 18 and 22 through 29, the handler I/O port may ignore the “Low” state of control input signals. When the threshold voltage for TTL-Low level is too low (lower than 0.5 V), it is possible that control input signal does not cross the threshold voltage (V_{LTH}) though the “Low” level of the signal is within the recommended voltage range (0 V to 0.5 V). As a result, a handler interface error occurs. See Figure 1.

Figure 1. Threshold voltage anomaly

When the threshold voltage of the handler I/O (either of the I/O pins) is too low, replace the A23 Handler I/O board with new one (P/N E5070-61006).
