E5070B-08D

S E R V I C E N O T E

E5070B ENA Series Network Analyzer, 300 kHz to 3 GHz

When a measurement trace or output power shows troubles between 1.3 GHz and 2.1 GHz, replace A1 module with the latest one (E5071-6x571), and update E5070B Operating system at the same time.

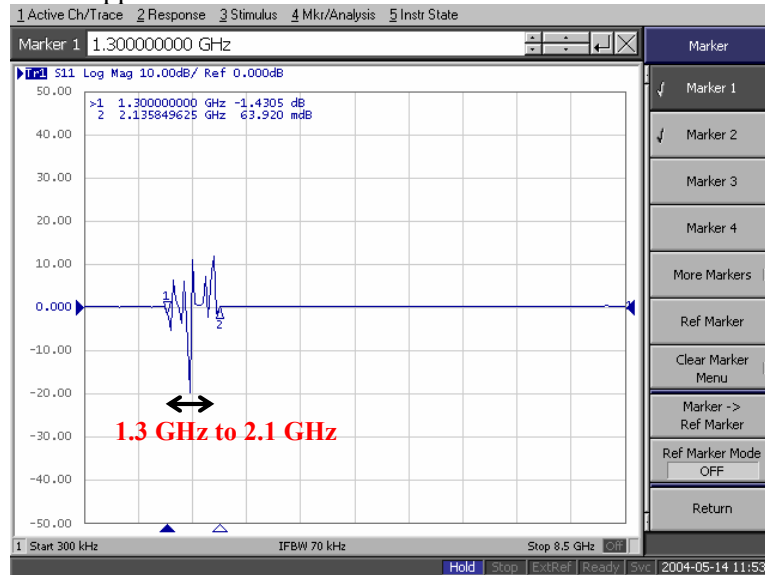
When the high-failure rate part has defective, the unit cannot output correct power level source or local signal, between 1.3 GHz and 2.1 GHz frequency range.

Above symptoms tend to appear after 30-minute heat run.

Figure 1. Trace shows noise around 1.3 GHz to 2.1 GHz at preset setting.

Replace the defective board with E5071-6x571, new A1 module. Also, update the operating system in accordance with the service note E5070B-10A to implement the firmware revision 5.00 or later. *1

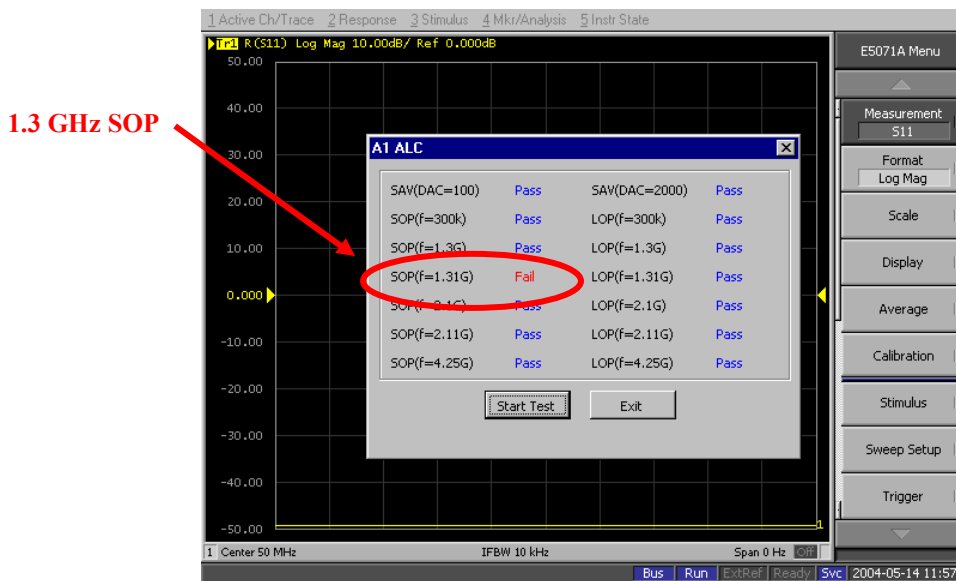
- The trace shows spike at 1.3 GHz or 2.1 GHz at the preset situation.
- The trace between 1.3 GHz to 2.1 GHz is more noisy than other frequency ranges.
- The power level of 1.3 GHz to 2.1 GHz is lower than other frequency ranges.
- Internal test of A1 ALC shows fail at SOP (f=1.3G) or LOP (f=1.3G) as Figure 2.

Figure 2. A1 ALC in Internal test has failure at SOP (f=1.3G) or LOP (f=1.3G)
