E5071A-05C

S E R V I C E N O T E

E5071A ENA Series Network Analyzer, 300 kHz to 8.5 GHz

Serial Numbers: JP1KJ00000 to JP1KJ00405

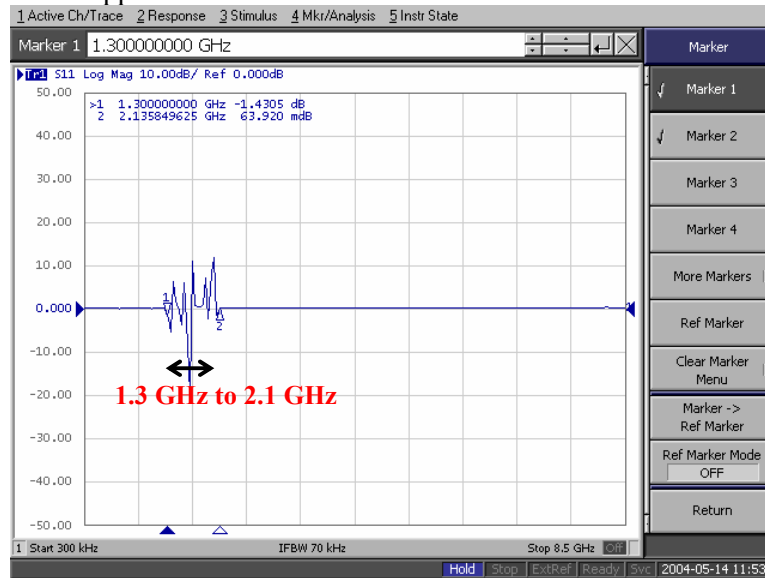
When the high-failure rate part has defective, the unit cannot output correct power level source or local signal, between 1.3 GHz and 2.1 GHz frequency range.

Above symptoms tend to appear after 30-minute heat run.

Figure 1. Trace shows noise around 1.3 GHz to 2.1 GHz at preset setting.

When a measurement trace or output power shows troubles between 1.3 GHz and 2.1 GHz, or in full frequency range, replace A1 module with the latest one (E5071-6x571), and update E5071A Operating System at the same time.

Update the E5070A operating system image referring to the service note E5071A-06B. Then, replace A1 module and perform the appropriate post repair procedures referring to the E5070A/E5071A service manual chapters 6 and 7.

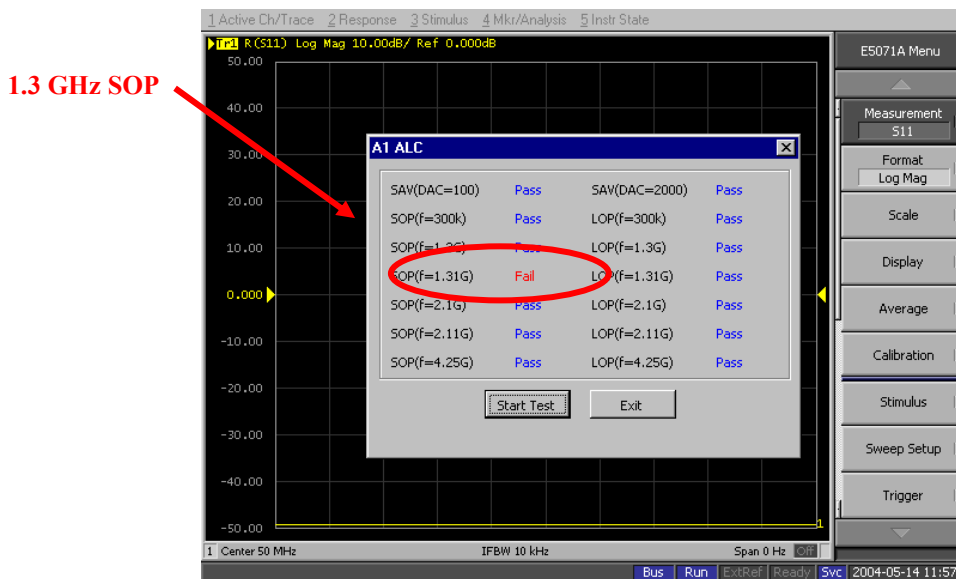
- The trace shows spike at 1.3 GHz or 2.1 GHz at the preset situation.
- The trace between 1.3 GHz to 2.1 GHz is more noisy than other frequency ranges.
- The power level of 1.3 GHz to 2.1 GHz is lower than other frequency ranges.
- Internal test of A1 ALC shows fail at SOP (f=1.3G) or LOP (f=1.3G) as Figure 2.

Figure 2. A1 ALC in Internal test has failure at SOP (f=1.3G) or LOP (f=1.3G)
