E5071B-08D

S E R V I C E N O T E

E5071B ENA Series Network Analyzer, 300 kHz to 8.5 GHz

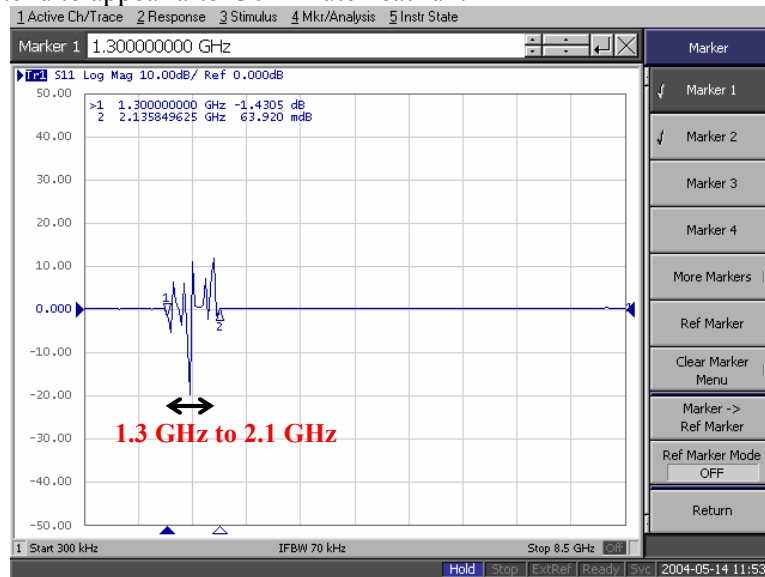
When the high-failure rate part has defective, the unit cannot output correct power level source or local signal, between 1.3 GHz and 2.1 GHz frequency range.

- The trace shows spike at 1.3 GHz or 2.1 GHz at the preset situation.
- The trace between 1.3 GHz to 2.1 GHz is more noisy than other frequency ranges.
- The power level of 1.3 GHz to 2.1 GHz is lower than other frequency ranges.
- Internal test of A1 ALC shows fail at SOP (f=1.3G) or LOP (f=1.3G) as Figure 2.

Figure 1. Trace shows noise around 1.3 GHz to 2.1 GHz at preset setting.

Replace the defective board with E5071-6x571, new A1 module. Also, update the operating system in accordance with the service note E5071B-10A to implement the firmware revision 5.00 or later. *1
