E8356A-03 <u>S E R V I C E N O T E</u>

E8356A PNA Microwave Network Analyzers

Serial Numbers: ALL

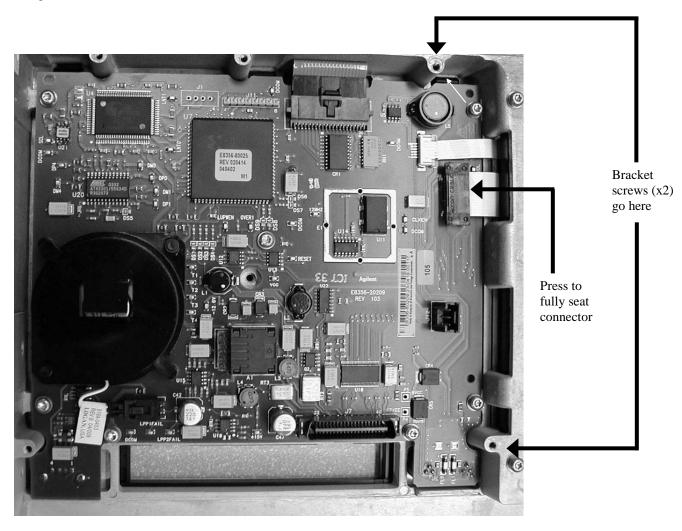
Figure 1: A3 Front Panel Interface Board Assy without the Bracket

A connector of the ribbon cable (Agilent part number 8120-8409) that joins the front panel display to the front panel interface board can loosen, causing a display failure, unless a new bracket is installed. Because the failure rate has been very low, it is recommended that the bracket be installed only when there is an additional reason to remove the PNA front panel.

- 1. Refer to Figure 1 in this document:
 - Press down firmly on the ribbon cable's black connector.
 - Locate the two tapped holes for the bracket screws.
- 2. As shown in Figure 2 in this document, position the bracket so that its holes line-up with the two holes you located in the previous step.
- 3. Hand-start the two screws, and then torque both to 9 in-lbs.
- 4. Reinstall the PNA Front Panel by following the Service Guide instructions in the "Replacement Procedure." This is located on the same page as the "Removal Procedure" used previously in step 7.
