E8357A-03

S E R V I C E N O T E

E8357A PNA Microwave Network Analyzers

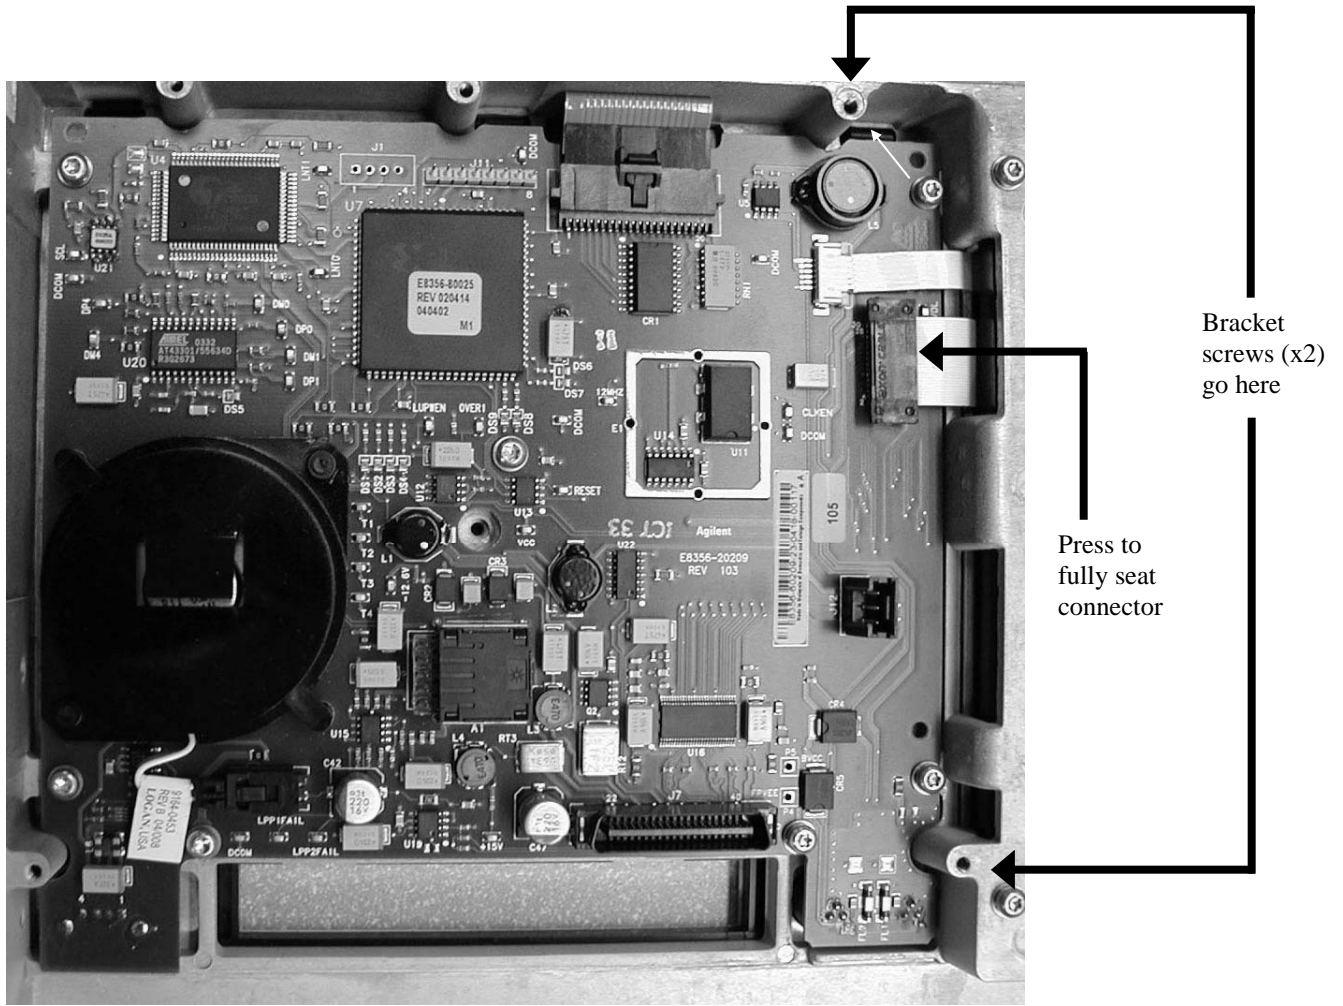
Figure 1: A3 Front Panel Interface Board Assy without the Bracket

A connector of the ribbon cable (Agilent part number 8120-8409) that joins the front panel display to the front panel interface board can loosen, causing a display failure, unless a new bracket is installed. Because the failure rate has been very low, it is recommended that the bracket be installed only when there is an additional reason to remove the PNA front panel.

1. Refer to Figure 1 in this document:
 - Press down firmly on the ribbon cable's black connector.
 - Locate the two tapped holes for the bracket screws.
2. As shown in Figure 2 in this document, position the bracket so that its holes line-up with the two holes you located in the previous step.
3. Hand-start the two screws, and then torque both to 9 in-lbs.
4. Reinstall the PNA Front Panel by following the Service Guide instructions in the "Replacement Procedure." This is located on the same page as the "Removal Procedure" used previously in step 7.
