E8361A-08

S E R V I C E N O T E

E8361A PNA Series RF Network Analyzers

Replace Inverter board (0950-3379) due to faulty component.

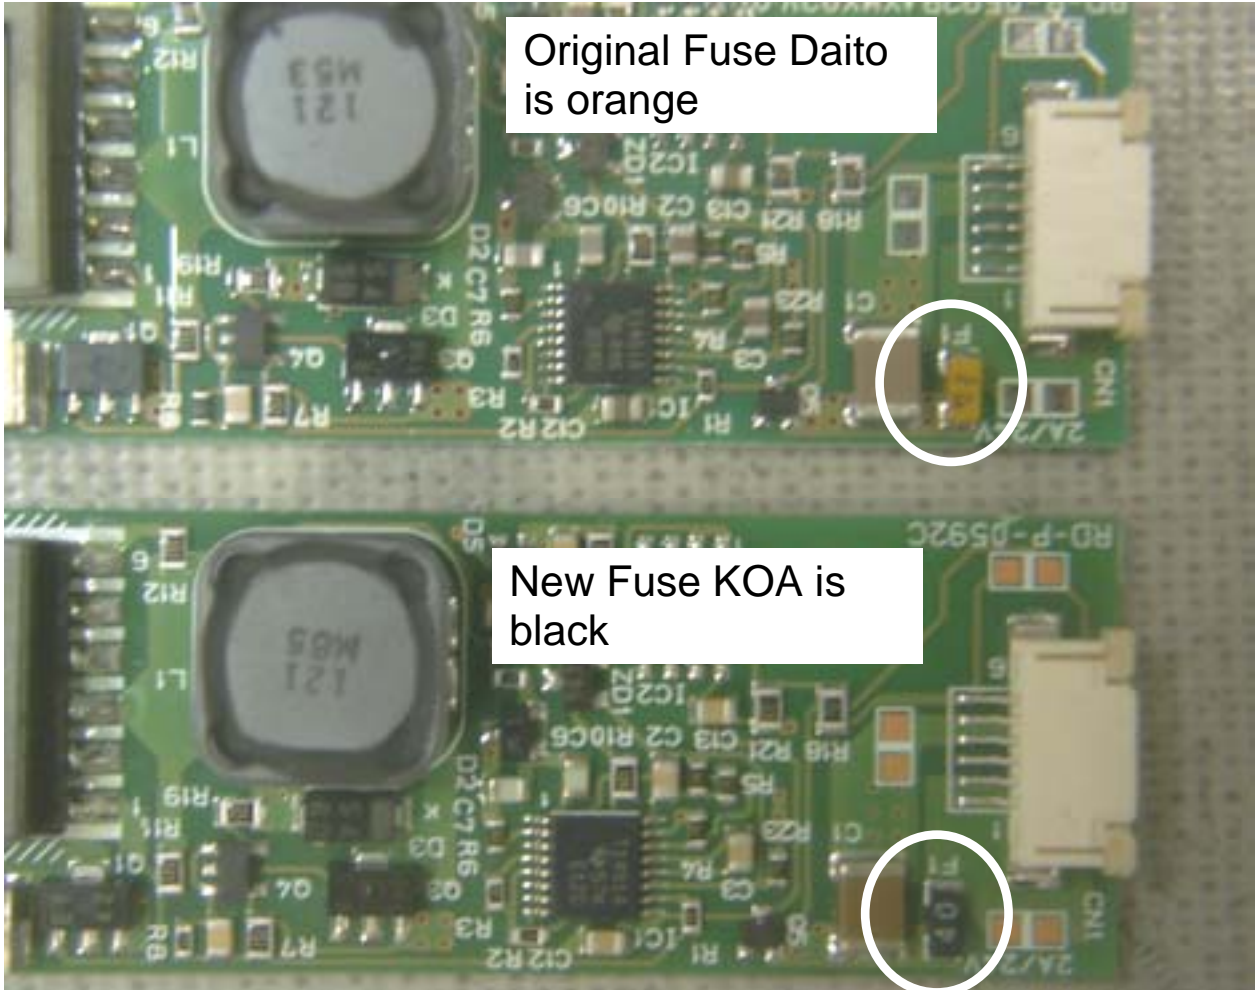
The original fuse (see photo) in the DC/AC Inverter board (p/n 0950-3379) is prone to failure in normal use.

Replace the Inverter board with a board containing the new fuse (see photo).
