E8363A-01C

S E R V I C E N O T E

E8363A PNA Series RF Network Analyzers

Serial Numbers: 00000000 thru 46999999

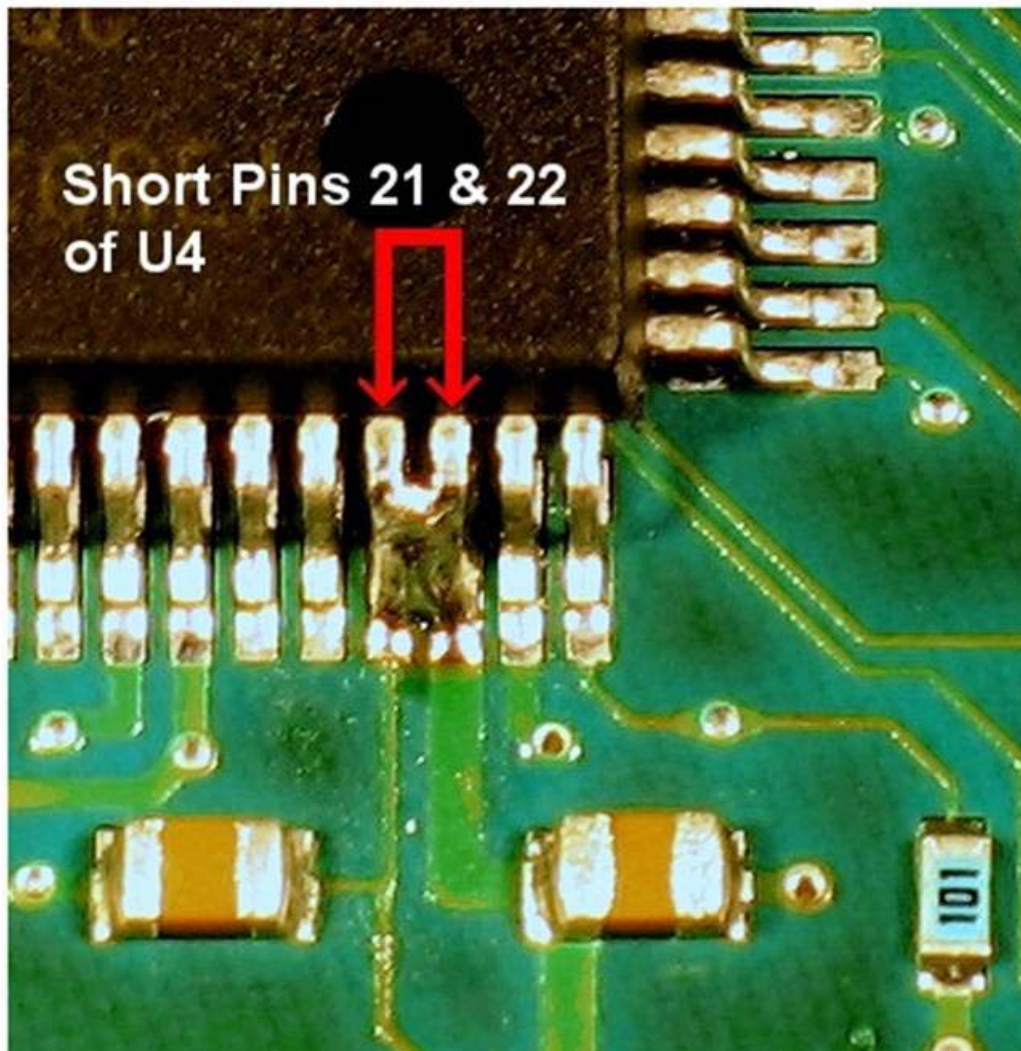
Both intermittent problems have been traced to an incorrect voltage applied to a pin on the U4 IC.

Carefully solder pins 21 and 22 together on U4. Refer to Figure 2 for the exact location. Use care so that no other pins are shorted. Use of a very fine tip soldering iron is recommended and a large work-task magnifying glass is very helpful.
