**E8363B-06**

**S E R V I C E N O T E**

**E8363B PNA Series RF Network Analyzers**

**Replace Inverter board (0950-3379) due to faulty component.**

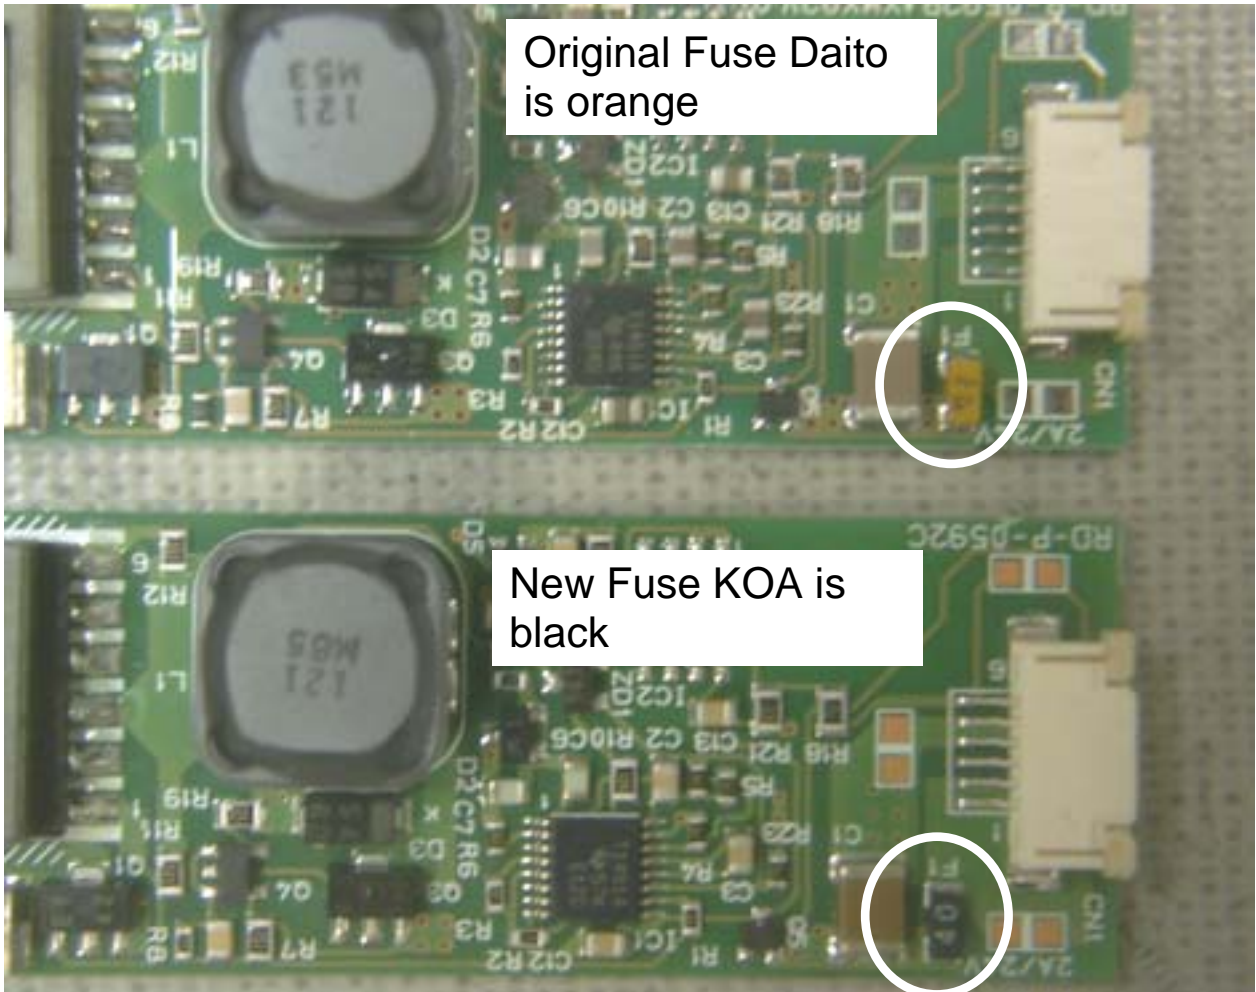
The original fuse (see photo) in the DC/AC Inverter board (p/n 0950-3379) is prone to failure in normal use.

Replace the Inverter board with a board containing the new fuse (see photo).
