E8802A-02

S E R V I C E N O T E

E8802A PNA Microwave Network Analyzers

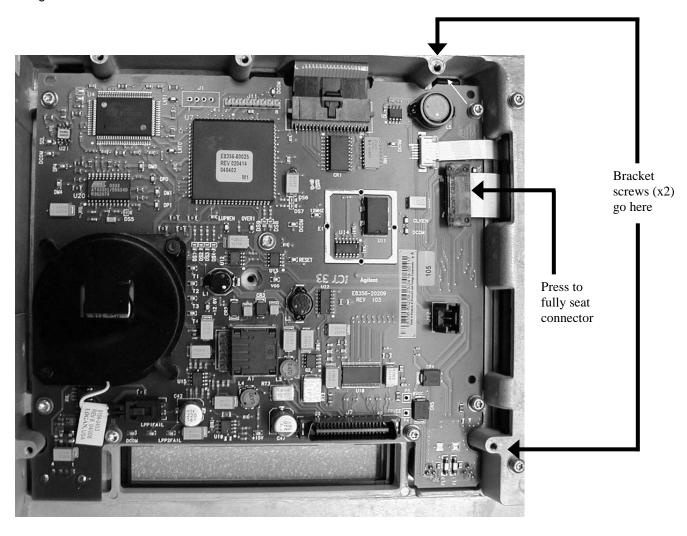
Figure 1: A3 Front Panel Interface Board Assy without the Bracket

- 1. Refer to Figure 1 in this document:
 - Press down firmly on the ribbon cable's black connector.
 - Locate the two tapped holes for the bracket screws.
- 2. As shown in Figure 2 in this document, position the bracket so that its holes line-up with the two holes you located in the previous step.
- 3. Hand-start the two screws, and then torque both to 9 in-lbs.
- 4. Reinstall the PNA Front Panel by following the Service Guide instructions in the "Replacement Procedure." This is located on the same page as the "Removal Procedure" used previously in step 7.

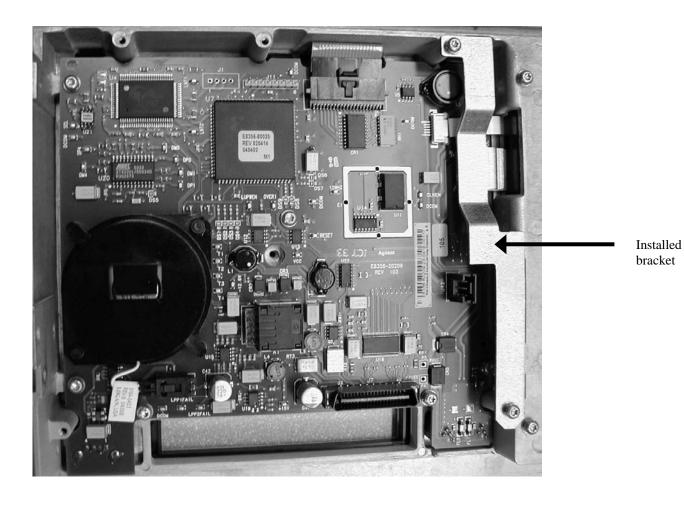
Figure 2: A3 Front Panel Interface Board Assy with the Bracket Installed
