E8802A-05

SERVICE NOTE

E8802A PNA Series RF Network Analyzers

Replace Inverter board (0950-3379) due to faulty component.

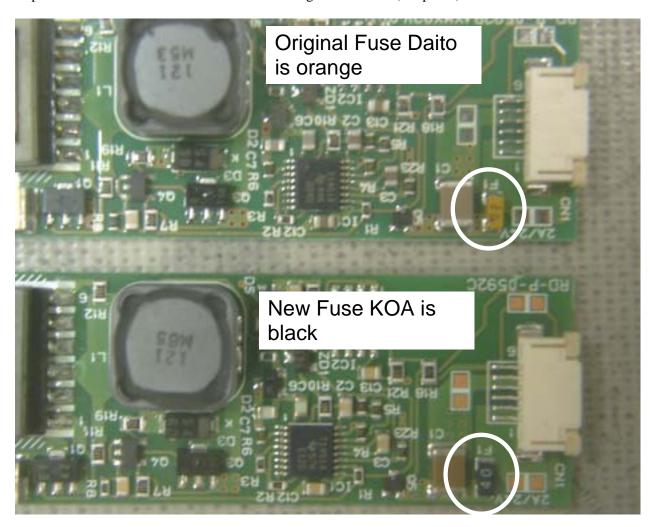
The original fuse (see photo) in the DC/AC Inverter board (p/n 0950-3379) is prone to failure in normal use.

Replace the Inverter board with a board containing the new fuse (see photo).
