E8803A-05

SERVICE NOTE

E8803A PNA Series RF Network Analyzers

Replace Inverter board (0950-3379) due to faulty component.

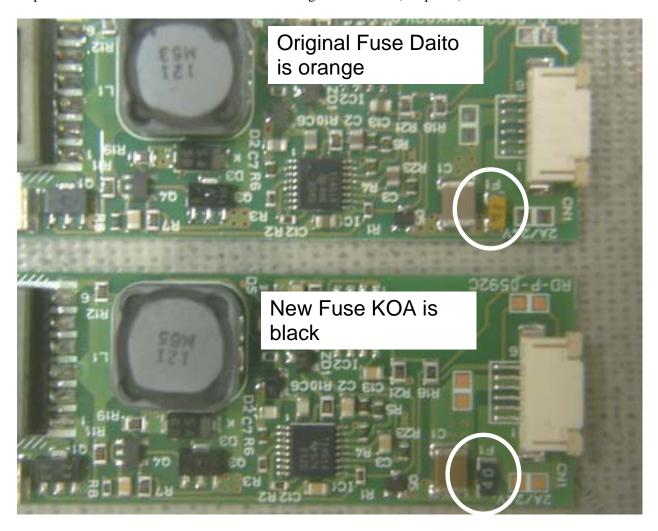
The original fuse (see photo) in the DC/AC Inverter board (p/n 0950-3379) is prone to failure in normal use.

Replace the Inverter board with a board containing the new fuse (see photo).
