**E4419B-19A**

**S E R V I C E N O T E**

**Agilent E4418/19 EPM Peak & Average Power Meter**

**Hot plugging problem Caused by Intersil component part number – MPN DG411DY**

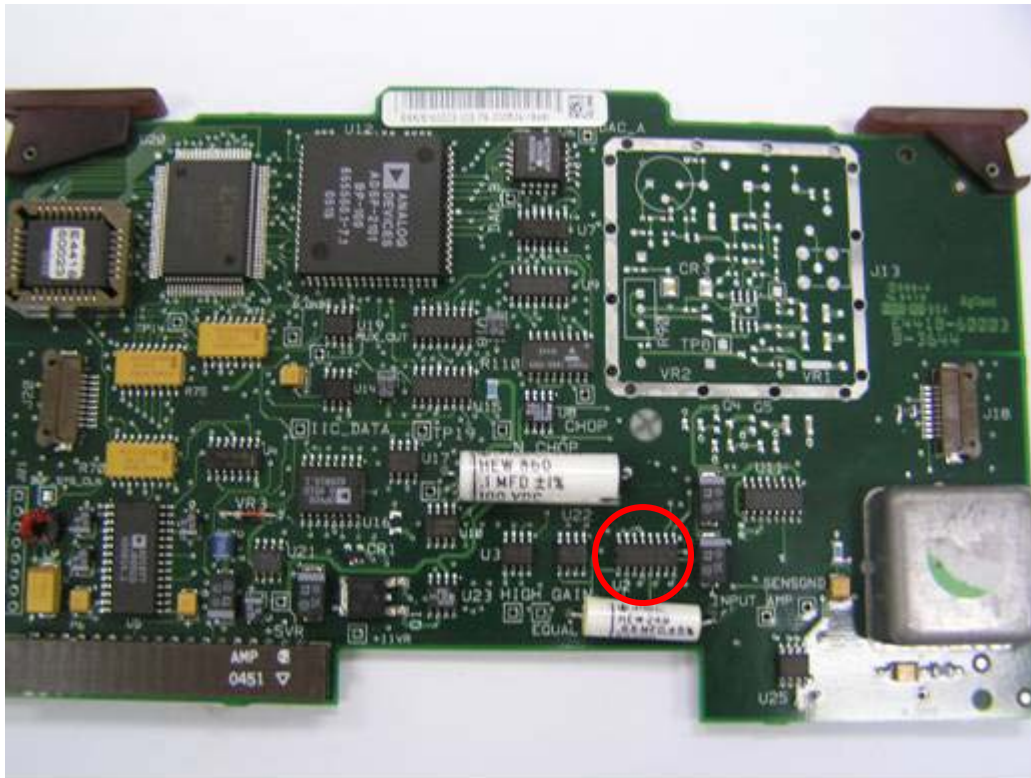
Fig 1: Measurement Board, A3

1.) This is a measurement board, E4418-60003 or A3 shown in figure 1.

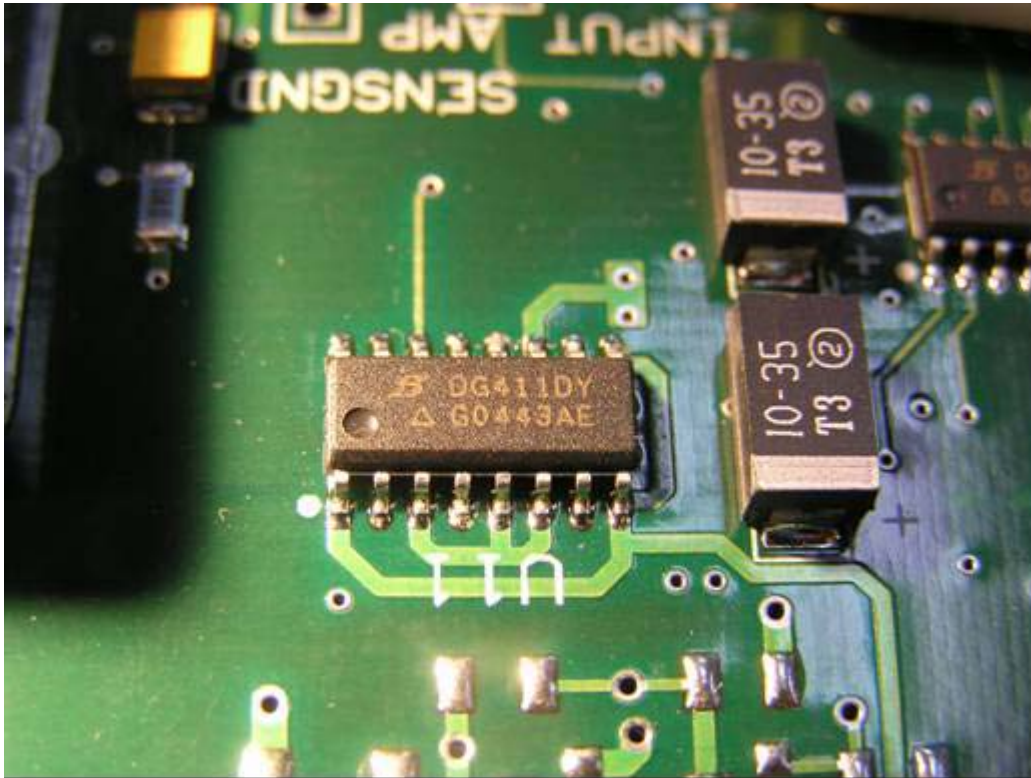
**Fig 2: Intersil Component, DG411DY**

From the studies has been found that only the component supplied from **Intersil** brand is contributed to hot plugging problem. This analog switch component with part number DG411DY printed on the IC component indicating it is Intersil brand.

- 2.) The figure 2 will be zooming to measurement board, A3 with Intersil supplier (U11) analog switch component.

The problematic measurement board will be encouraged to be replaced by good measurement board which consists **without** of (U11) analog switch component of Intersil brand (marked with DG411DY) and shown in figure 2 below.

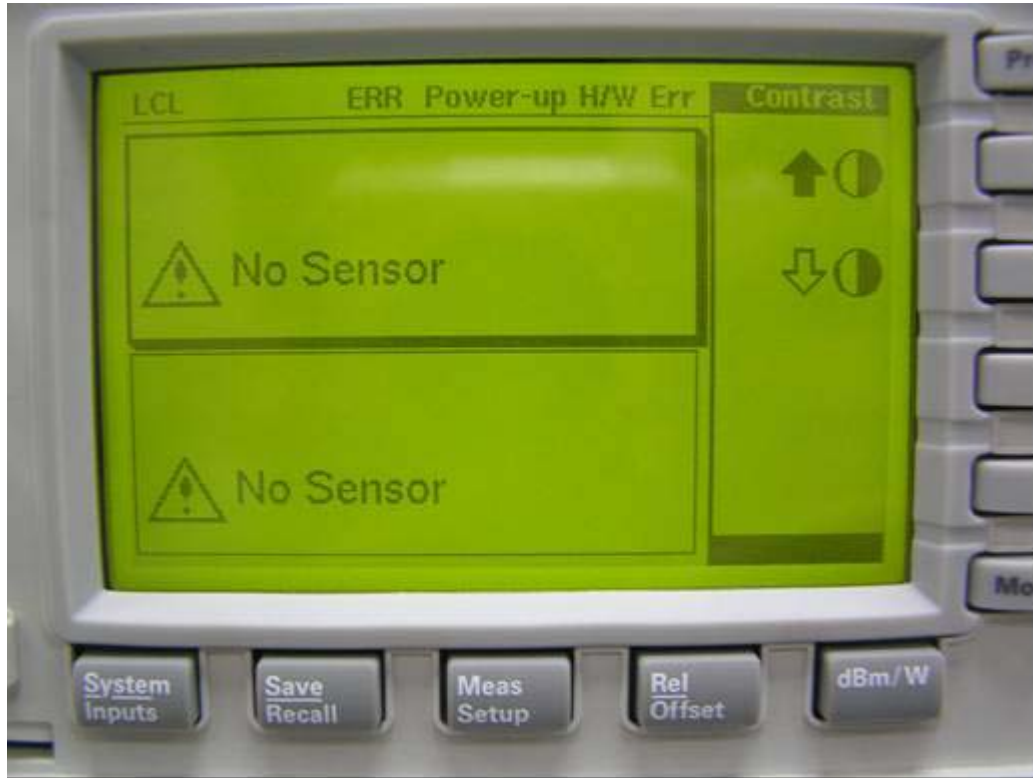
**Figure 3: No Sensor Detected while  
Sensor is connecting**

This problem happened on power meter, E441x when the front panel power Off/On switch turned on first and direct plug out the power cord from the meter and on it back. Then the power meter will be hung up from time to time and an error message will be displayed and shown in figure 3 below. To get the power meter in operation mode again the system operator needs to manually PRESET the power meter.

The problematic measurement board will be shown no sensor in figure 3. Mean time, the function/good measurement board would show sensor detected in figure 4 below.

### 3.) Hardware Power Up Error or No Sensor Detected

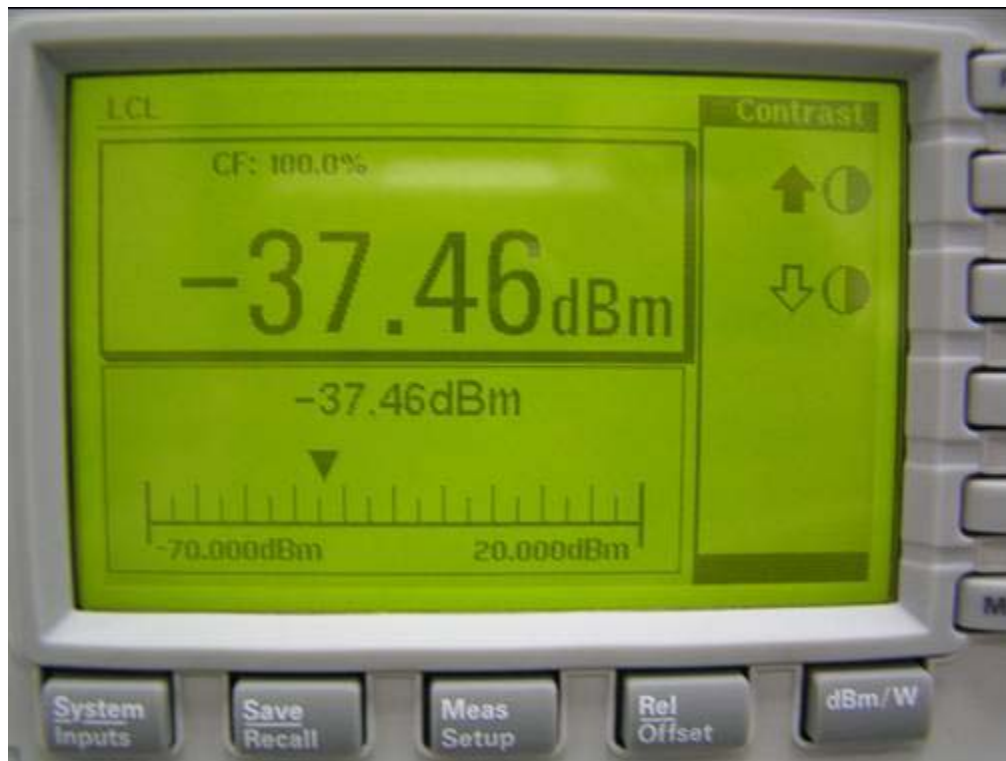
**Fig 4: Good Measurement Board with Sensor Detected**

#### 4.) Sensor Detected with Good Measurement Board

After replacing the good measurement board used with other brand of Intersil component. Direct power off and on back the power meter while front panel power switch “on” first from power meter. The result will indicate there is a sensor detected and shown in figure 4 below.
