S E R V I C E N O T E

E4400A RF Signal Generator

Replacement Procedure for Q501 on Motherboard/CPU

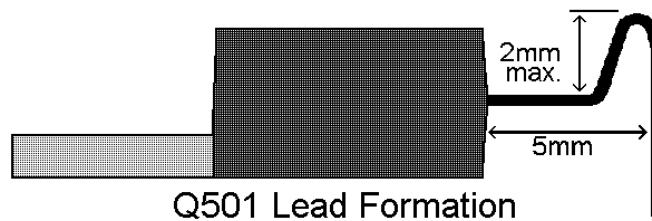
A large proportion of motherboard failures have been caused by stress fractures internal to Q501, the series-pass transistor for the +9 volt power supply.

Obtain a new transistor and bend all three leads with needle nose pliers as shown in the drawing below. This may take some practice so it helps to order several replacement transistors. This lead formation is done to prevent future failures caused by stress fractures.

Insert the transistor into the motherboard but do NOT solder it yet. Use the shoulder washer and screw to fasten the transistor, making sure the shoulder washer is properly seated. Once the transistor is mechanically secured, it may be soldered from either the top or bottom side of the board. Using an ohmmeter, verify the transistor's tab is not shorted to ground.
