11757B-02

S E R V I C E N O T E

HP 11757B Multipath Fading Simulator

11757B-02 Modification Diagram

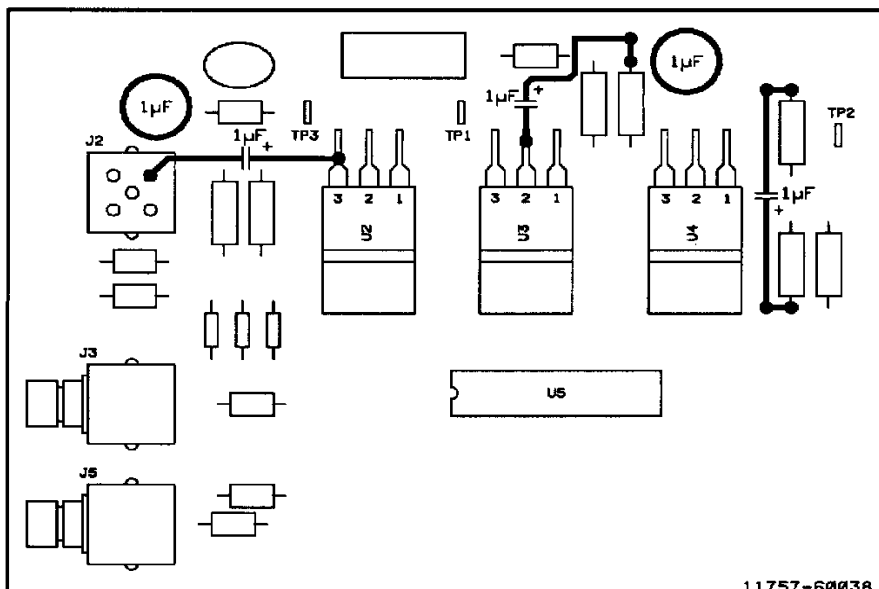
Some spurs 50KHz - 300KHz offset from the carrier, greater than the -67dBc specification for the RF source were observed on a few production units (11758). The problem was isolated to the EEPROM/Counter Board, both the current (11757-60056) and older (11757-60038) assemblies, on the U2, U3, and U4 regulators. The fix was to add 1uF capacitors to the input and output of the regulators as described in the regulator's application notes. This makes the regulators optimally stable and eliminates oscillations which were causing the spurs on the RF source's signal. The older board (11757-60038) can be retrofitted with a field installable modification (described in this service note) rather than replacing the board with its direct replacement, the Counter/EPROM Upgrade Kit (11757-60059). This eliminates the need to scrap the old board and order both the new board and new firmware contained in the kit. The updated older board (11757-60038) will become 11757-60061 after the fix is implemented. Similarly, the 11757-60056 can be modified and would become 11757-60060.

1. Place board on a bench equipped with an ESD mat. Make sure person performing this modification is grounded also. Observe all normal ESD precautions while this procedure is being followed.
2. Make sure that all exposed capacitor leads are covered with the insulating tubing to prevent contact with other points on the board.
3. Attach the non-polarized lead from a 1uF capacitor (0180-4129) to pin 2 of U3 and solder it.
4. Unsolder the lead of R7 closest to the edge of the pc board and solder a post connector into the hole. Re-attach R7 to the post as well as the polarized (plus) lead of the 1uF capacitor that was soldered to U3 pin 2.

5. Unsolder opposing leads of R30 and R10 (see diagram) and solder post connectors into both locations. Re-attach respective leads for R30 and R10 as well as leads for a 1uF electrolytic capacitor (0180-4129). Make sure polarized (plus) end of the capacitor goes to the R30 lead.

6. Attach the polarized (plus) lead of a 1uF electrolytic capacitor (0180-4129) to pin 3 of U2 and solder it. Remove the solder from the J2 ground hole indicated on the diagram, insert the remaining capacitor lead and solder.

7. Remove both capacitors C11 and C9 and replace with 1uF capacitors (0180-3771). Note that since these are three-lead items, it does not matter which way the capacitors are oriented.
