11758U-01

S E R V I C E N O T E

HP 11758U Digital Radio Test System

DATE: 12 August 1993

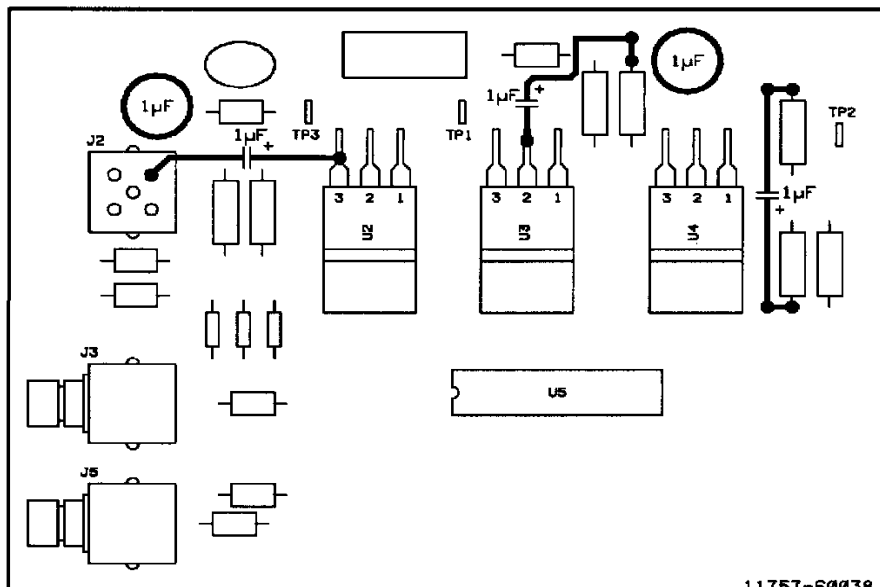
11757B-02 Modification Diagram

Some spurs 50KHz - 300KHz offset from the carrier, greater than the -67dBc specification for the RF source were observed on a few production units (11758). The problem was isolated to the EEPROM/Counter Board, both the current (11757-60056) and older (11757-60038) assemblies, on the U2, U3, and U4 regulators. The fix was to add 1uF capacitors to the input and output of the regulators as described in the regulator's application notes. This makes the regulators optimally stable and eliminates oscillations which were causing the spurs on the RF source's signal. The older board (11757-60038) can be retrofitted with a field installable modification (described in this service note) rather than replacing the board with its direct replacement, the Counter/EPROM Upgrade Kit (11757-60059). This eliminates the need to scrap the old board and order both the new board and new firmware contained in the kit. The updated older board (11757-60038) will become 11757-60061 after the fix is implemented. Similarly, the 11757-60056 can be modified and would become 11757-60060.

1. Place board on a bench equipped with an ESD mat. Make sure person performing this modification is grounded also. Observe all normal ESD precautions while this procedure is being followed.
2. Make sure that all exposed capacitor leads are covered with the insulating tubing to prevent contact with other points on the board.
3. Attach the non-polarized lead from a 1uF capacitor (0180-4129) to pin 2 of U3 and solder it.

4. Unsolder the lead of R7 closest to the edge of the pc board and solder a post connector into the hole. Re-attach R7 to the post as well as the polarized (plus) lead of the 1uF capacitor that was soldered to U3 pin 2.

5. Unsolder opposing leads of R30 and R10 (see diagram) and solder post connectors into both locations. Re-attach respective leads for R30 and R10 as well as leads for a 1uF electrolytic capacitor (0180-4129). Make sure polarized (plus) end of the capacitor goes to the R30 lead.

6. Attach the polarized (plus) lead of a 1uF electrolytic capacitor (0180-4129) to pin 3 of U2 and solder it. Remove the solder from the J2 ground hole indicated on the diagram, insert the remaining capacitor lead and solder.

7. Remove both capacitors C11 and C9 and replace with 1uF capacitors (0180-3771). Note that since these are three-lead items, it does not matter which way the capacitors are oriented.
