11758V-01

S E R V I C E N O T E

HP 11758V Digital Radio Test System

11757B-02 Modification Diagram

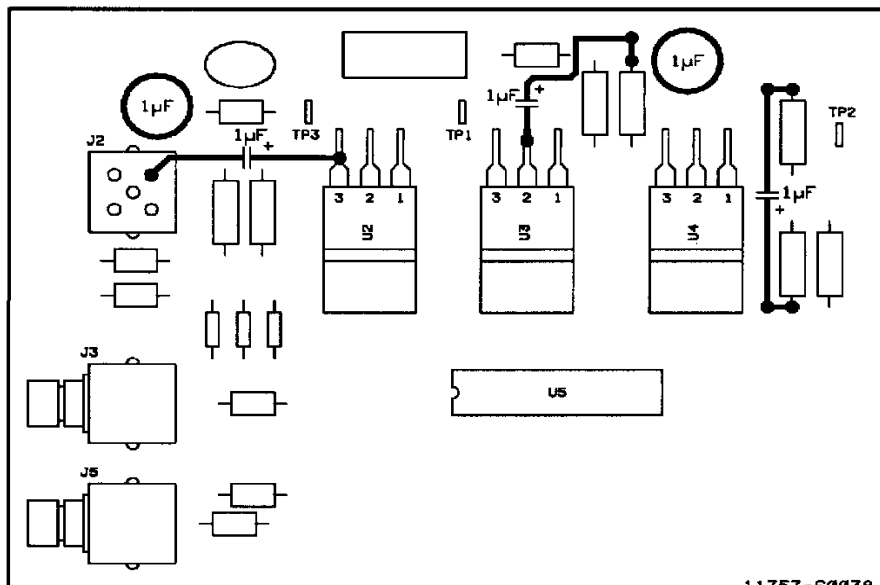
Some spurs 50KHz - 300KHz offset from the carrier, greater than the -67dBc specification for the RF source were observed on a few production units (11758). The problem was isolated to the EEPROM/Counter Board, both the current (11757-60056) and older (11757-60038) assemblies, on the U2, U3, and U4 regulators. The fix was to add 1uF capacitors to the input and output of the regulators as described in the regulator's application notes. This makes the regulators optimally stable and eliminates oscillations which were causing the spurs on the RF source's signal. The older board (11757-60038) can be retrofitted with a field installable modification (described in this service note) rather than replacing the board with its direct replacement, the Counter/EPROM Upgrade Kit (11757-60059). This eliminates the need to scrap the old board and order both the new board and new firmware contained in the kit. The updated older board (11757-60038) will become 11757-60061 after the fix is implemented. Similarly, the 11757-60056 can be modified and would become 11757-60060.

1. Place board on a bench equipped with an ESD mat. Make sure person performing this modification is grounded also. Observe all normal ESD precautions while this procedure is being followed.
2. Make sure that all exposed capacitor leads are covered with the insulating tubing to prevent contact with other points on the board.
3. Attach the non-polarized lead from a 1uF capacitor (0180-4129) to pin 2 of U3 and solder it.

4. Unsolder the lead of R7 closest to the edge of the pc board and solder a post connector into the hole. Re-attach R7 to the post as well as the polarized (plus) lead of the 1uF capacitor that was soldered to U3 pin 2.

5. Unsolder opposing leads of R30 and R10 (see diagram) and solder post connectors into both locations. Re-attach respective leads for R30 and R10 as well as leads for a 1uF electrolytic capacitor (0180-4129). Make sure polarized (plus) end of the capacitor goes to the R30 lead.

6. Attach the polarized (plus) lead of a 1uF electrolytic capacitor (0180-4129) to pin 3 of U2 and solder it. Remove the solder from the J2 ground hole indicated on the diagram, insert the remaining capacitor lead and solder.

7. Remove both capacitors C11 and C9 and replace with 1uF capacitors (0180-3771). Note that since these are three-lead items, it does not matter which way the capacitors are oriented.
