11759C-01

S E R V I C E N O T E

**HP 11759C RF Channel Simulator**

**220VAC Line Module Miswire**

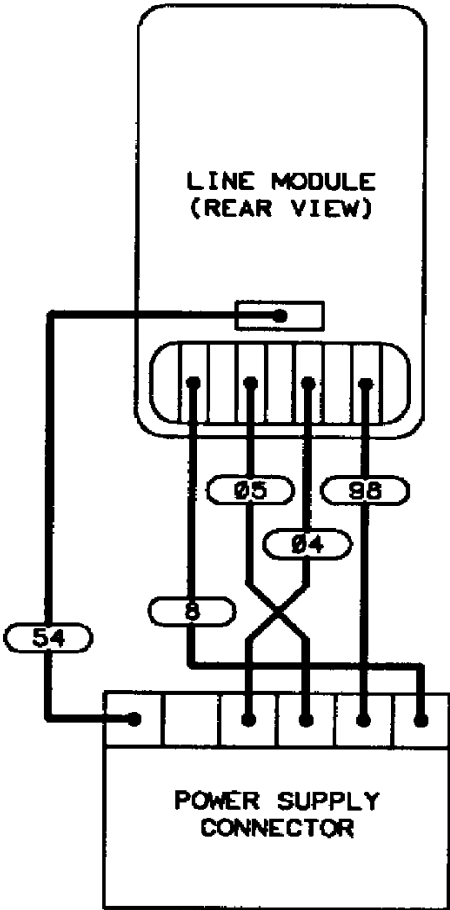
Instruments within the above serial number range may have a miswire in the wiring harness that connects the line module to the power supply module. This will cause the unit to blow line fuses while attempting to power up using 220VAC, but will function normally using 110VAC. The power supply can be affected as the gas-tube crowbar fires in an attempt to protect the power supply from the effects of the miswire.

The shrink wrap tubing can be cut from the solder lugs on the line module and the wiring altered to match the diagram below. Please note that the ground wire (green/yellow) and the gray wire need not be touched. Also note that the two capacitors on the line module leads should remain in their positions and should be securely soldered. Shrink tubing should be installed on the line module leads as part of this repair procedure. When the wiring has been altered to match the diagram in this service note, the line module and harness can be installed by reversing the removal procedure described above.
