## 8561EC-04

# S E R V I C E N O T E

## 856xEC Series Portable Spectrum Analyzer

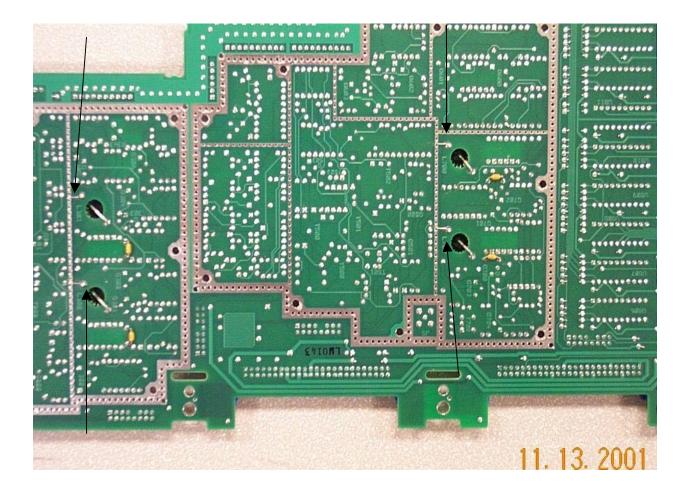
For the instruments specified above, inductors within the A5 IF assembly are not making good connections to ground thereby giving error messages related to the A4 Log Amp board. Error numbers that appear in the lower right-hand corner of the screen on account of this problem are errors 561, 562, and 565.

If the serial number of the instrument applies to the ones above, the following butch may solve the problem. Remove the shielding from the A5 IF assembly. Locate the inductors, and according to the attached photograph, insert and solder one end of the 8150-4222 wire into the hole connecting to the inductors and solder the other end to the ground plane on the front layer of the board. Do this for each inductor. See attached picture, the arrows point to where the jumpers are attached.

Add jumpers according to the picture above.
