8562EC-04

S E R V I C E N O T E

856xEC Series Portable Spectrum Analyzer

February 8, 2002

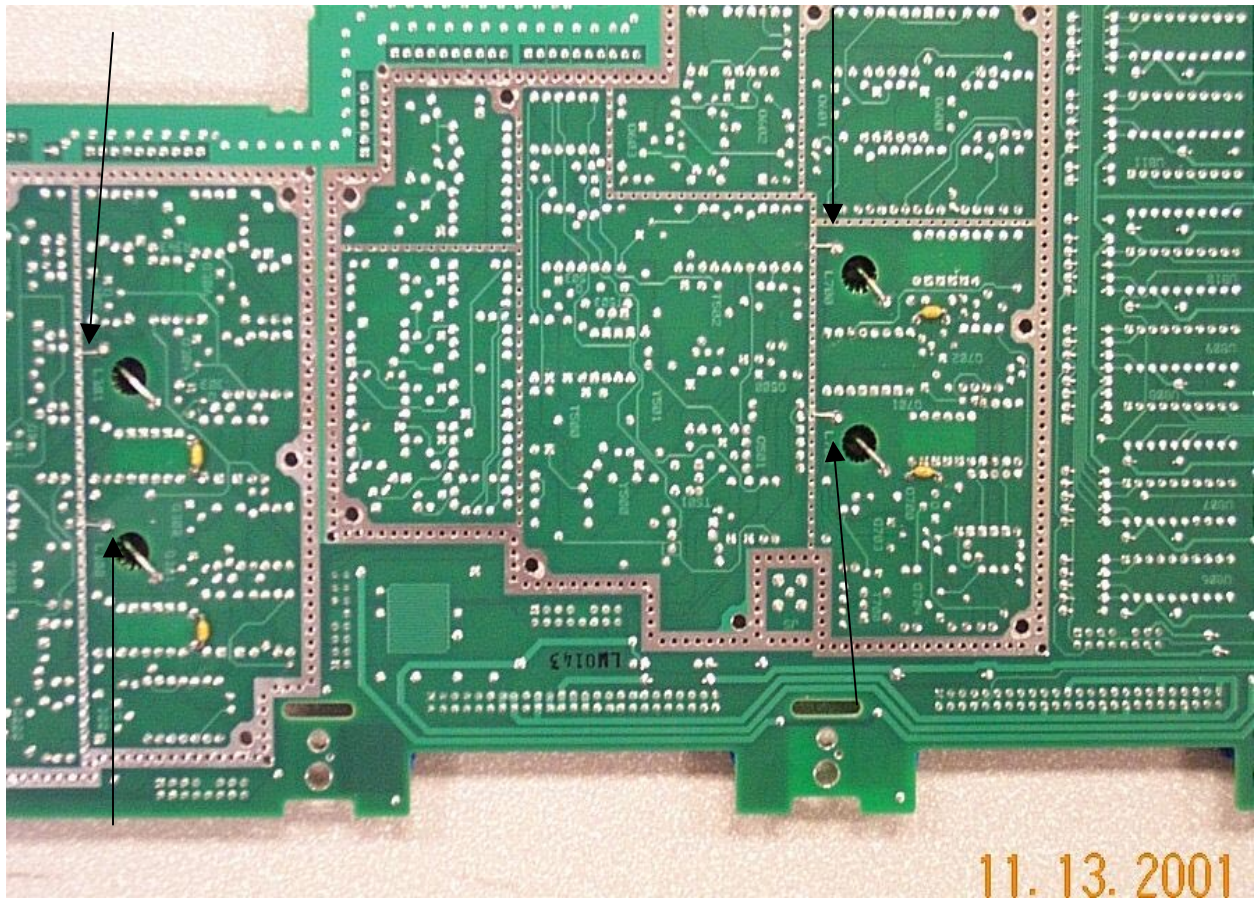
For the instruments specified above, inductors within the A5 IF assembly are not making good connections to ground thereby giving error messages related to the A4 Log Amp board. Error numbers that appear in the lower right-hand corner of the screen on account of this problem are errors 561, 562, and 565.

If the serial number of the instrument applies to the ones above, the following butch may solve the problem. Remove the shielding from the A5 IF assembly. Locate the inductors, and according to the attached photograph, insert and solder one end of the 8150-4222 wire into the hole connecting to the inductors and solder the other end to the ground plane on the front layer of the board. Do this for each inductor. See attached picture, the arrows point to where the jumpers are attached.

Add jumpers according to the picture above.
