8565EC-04

S E R V I C E N O T E

856xEC Series Portable Spectrum Analyzer

February 8, 2002

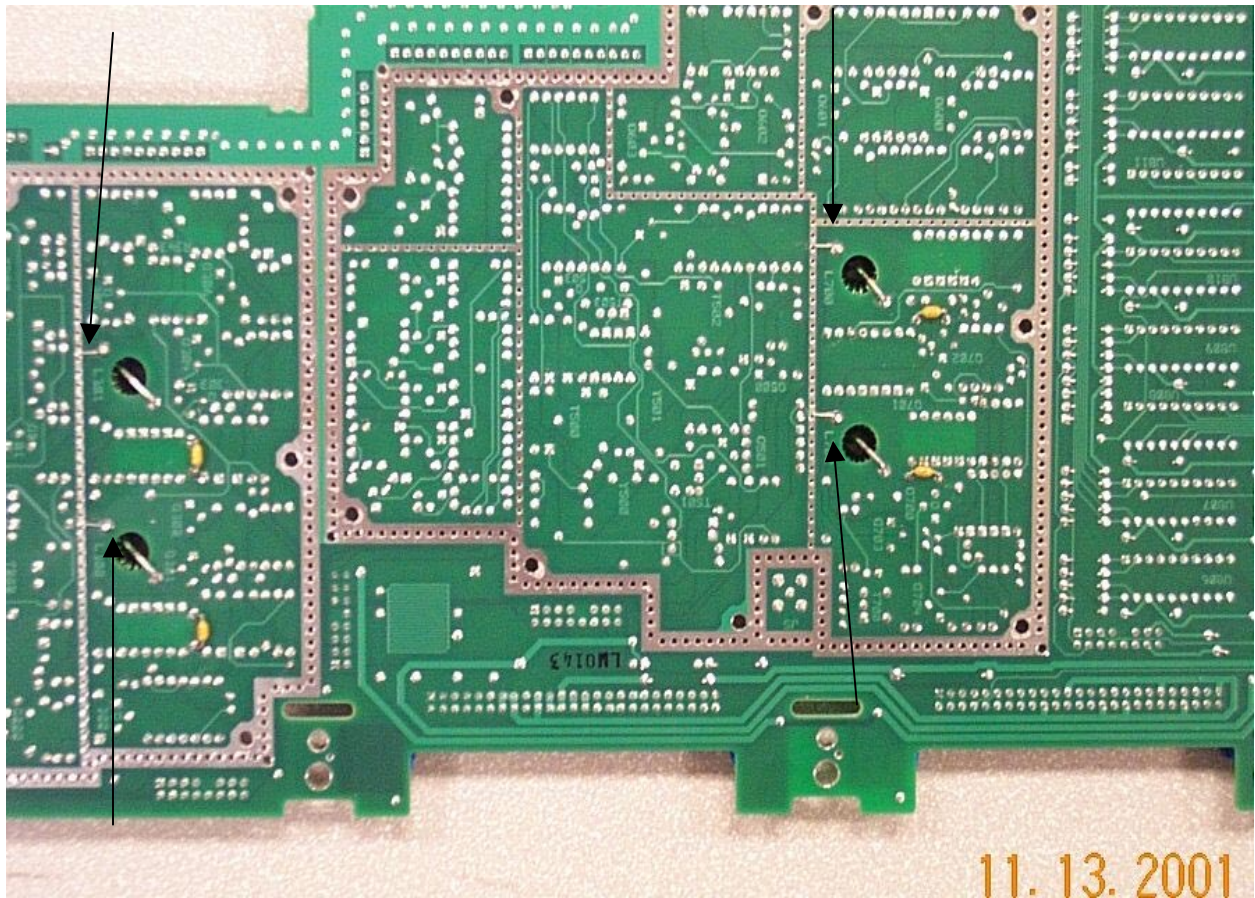
For the instruments specified above, inductors within the A5 IF assembly are not making good connections to ground thereby giving error messages related to the A4 Log Amp board. Error numbers that appear in the lower right-hand corner of the screen on account of this problem are errors 561, 562, and 565.

If the serial number of the instrument applies to the ones above, the following butch may solve the problem. Remove the shielding from the A5 IF assembly. Locate the inductors, and according to the attached photograph, insert and solder one end of the 8150-4222 wire into the hole connecting to the inductors and solder the other end to the ground plane on the front layer of the board. Do this for each inductor. See attached picture, the arrows point to where the jumpers are attached.

Add jumpers according to the picture above.
