8591C-14

S E R V I C E N O T E

8591C Cable TV Analyzer, 1 MHz-1.8 GHz

Replace C3 and U2 to prevent the audio circuitry from failing on the option 107, TV Demodulator Board.

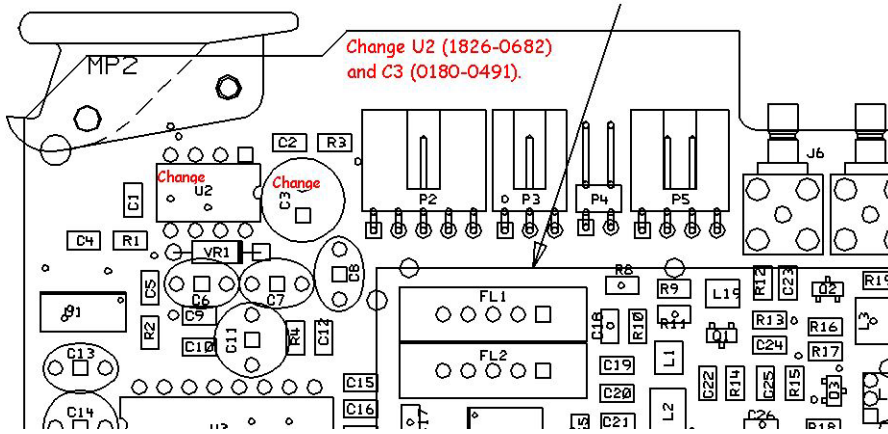
The audio output circuitry on the TV Demodulator board, part number 5063-1636 was found to be oscillating during the manufacturing process. One of the board modifications was to change capacitor C3, which changed from 100uF to 10uF. C3 was inserted backwards on the serial numbers specified above. If the capacitor breaks down, it will cause the audio portion of the TV output to fail, however it will not affect the testing of the TV signals. If the capacitor breaks down, it will also cause U2 to heat up.

Change both C3 and U2 if the serial number is within the range specified above to prevent the audio portion of the TV output from failing. See Fig. 1 for component locations.
