S E R V I C E N O T E

8593E Spectrum Analyzer

Modification to A14 Log Amplifier Assy to control overshoot problem

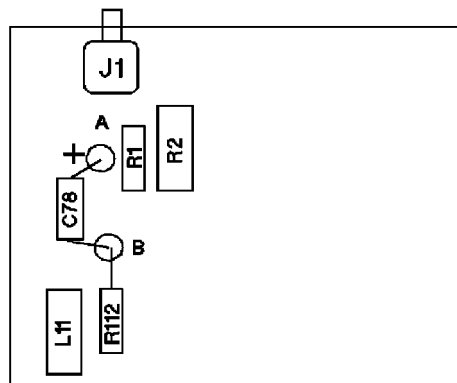
An overshoot problem has been observed when users make power vs time measurements on a PHS like signal even without the PHS DLP. The analyzer has this overshoot for fast turn on large dynamic range bursts (50 dB or so). This is generally associated with Digital Communication types of measurements.

A 10 ufd. capacitor is added to the +11 volt regulated circuit. The capacitor is actually tied to the +11 V2 output to ground. The effect of the capacitor is to suppress the overshoot that has been experienced as described in the Situation description.

1. Lift the top lead of R112 from the circuit board at Point B, see Figure 1.
2. Place the terminal stud (p/n 0360-0124) into Point B and solder in place.
3. Place the (+) end of the capacitor (C78) into the hole at Point A and solder into place.
4. Wrap the (-) lead of C78 and the loose lead of R112 around the terminal stud in Point B and solder.
5. Apply one label with the 08590-60373 imprinted to the assembly over the 5062-8261 part number and place one label on the rear panel for quick identification of the modified Log assembly.
