S E R V I C E N O T E

8594E Spectrum Analyzer

Counter-Lock Assembly modification to improve marker count stability under certain conditions.

8594E-02

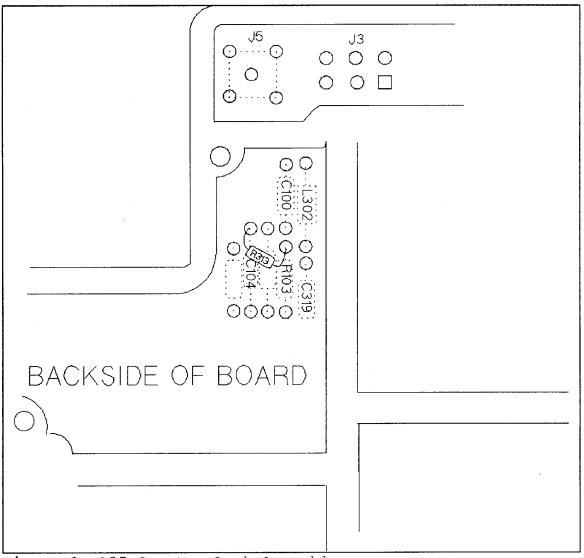
Figure 1. A25 Counter-Lock Assembly

Instruments which have the A25 Counter Lock Assembly with P/N 08591-60053 or 08591-60061 may experience non-stable marker count readings. These non-stable counts are a problem while using marker count on AM modulated signals in wide Resolution BW's. When counting AM modulated signals (like the visual carrier of a TV signal) we have un-wanted modulation (15.7KHz sync rate) on the VIDEO_IF signal being combined with the COUNTER 21.4MHz input signal.

Add a high-pass filter circuit (corner freq of 1.4MHz) to the COUNT IF1(Block M) circuit which blocks the unwanted low frequency modulation signal and allows the 21.4MHz to pass through with very little loss.

- 2. Remove the screw securing the two halves of the casting. Separate the casting halves and place the assembly bottom side up on the work surface.
- 3. Refer to Figure 1. for the location of R103 and remove R103. Install C321 in place of R103 but do not solder at this time. Install R313 as shown in Figure 1. One lead will share a hole with C321 (just installed). The other lead will share a hole with C104 as shown.
- 4. Apply the label (08591-60073) over the old board number.
- 5. Apply a label (08591-60073) onto the rear panel for future reference.
