8594E-10

S E R V I C E N O T E

**8594E Spectrum Analyzer**

**Modification to A14 Log Amplifier Assy to control overshoot problem**

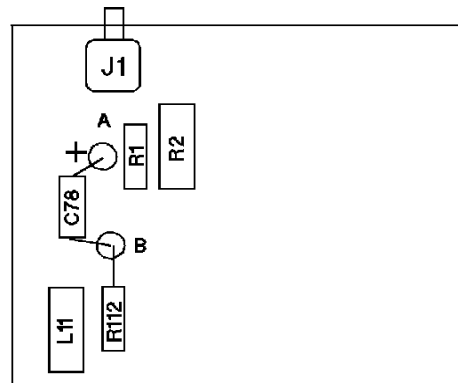
An overshoot problem has been observed when users make power vs time measurements on a PHS like signal even without the PHS DLP. The analyzer has this overshoot for fast turn on large dynamic range bursts (50 dB or so). This is generally associated with Digital Communication types of measurements.

A 10 ufd. capacitor is added to the +11 volt regulated circuit. The capacitor is actually tied to the +11 V2 output to ground. The effect of the capacitor is to suppress the overshoot that has been experienced as described in the Situation description.

1. Lift the top lead of R112 from the circuit board at Point B, see Figure 1.
2. Place the terminal stud (p/n 0360-0124) into Point B and solder in place.
3. Place the (+) end of the capacitor (C78) into the hole at Point A and solder in place.
4. Wrap the (-) lead of C78 and the loose lead of R112 around the terminal stud in Point B and solder.
5. Apply one label with the 08590-60373 imprinted to the assembly over the 5062-8261 part number and place one label on the rear panel for quick identification of the modified Log assembly.
