E4401B-10

S E R V I C E N O T E

E4401B 9 kHz to 1.5 GHz ESA Spectrum Analyzer

Replace Micron DRAM SIMMS from the A4, CPU assembly that can cause intermittent lock-up issues on instruments having option B72 only.

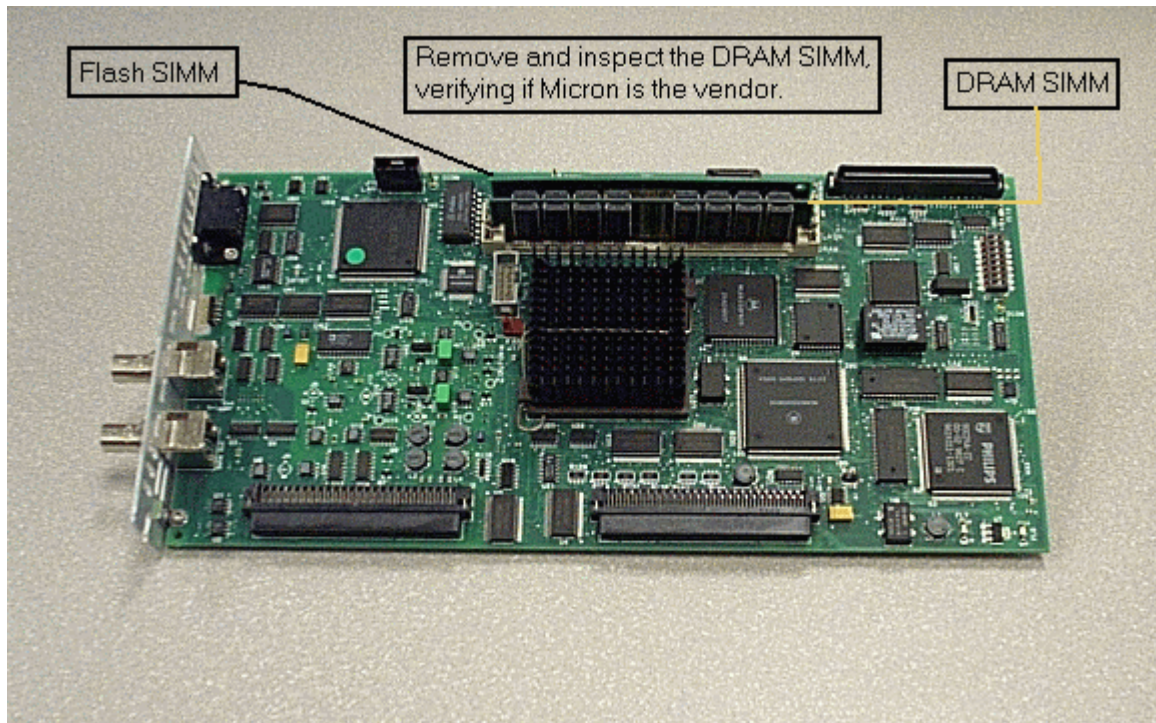
DRAM SIMMS using Micron parts can cause the instrument to lock-up and possibly white screen. This problem will only occur on instruments within the specified serial number range that have option B72, expanded memory. Micron has been removed from Agilent Technologies approved supplier list.

Remove the A4, CPU assembly from the instrument and pull out the DRAM SIMM pictured below. Additional information about removing the CPU assembly from the instrument can be found in the ESA or EMC Service Guide under chapter heading, "Replacing Assemblies". Inspect for Micron parts. If there is an "M" with a circle indicating the Micron parts, the SIMM should be replaced. All other component manufacturers are fine.
