E4402B-11

S E R V I C E N O T E

E4402B 9 kHz to 3.0 GHz ESA Spectrum Analyzer

Replace Micron DRAM SIMMS from the A4, CPU assembly that can cause intermittent lock-up issues on instruments having option B72 only.

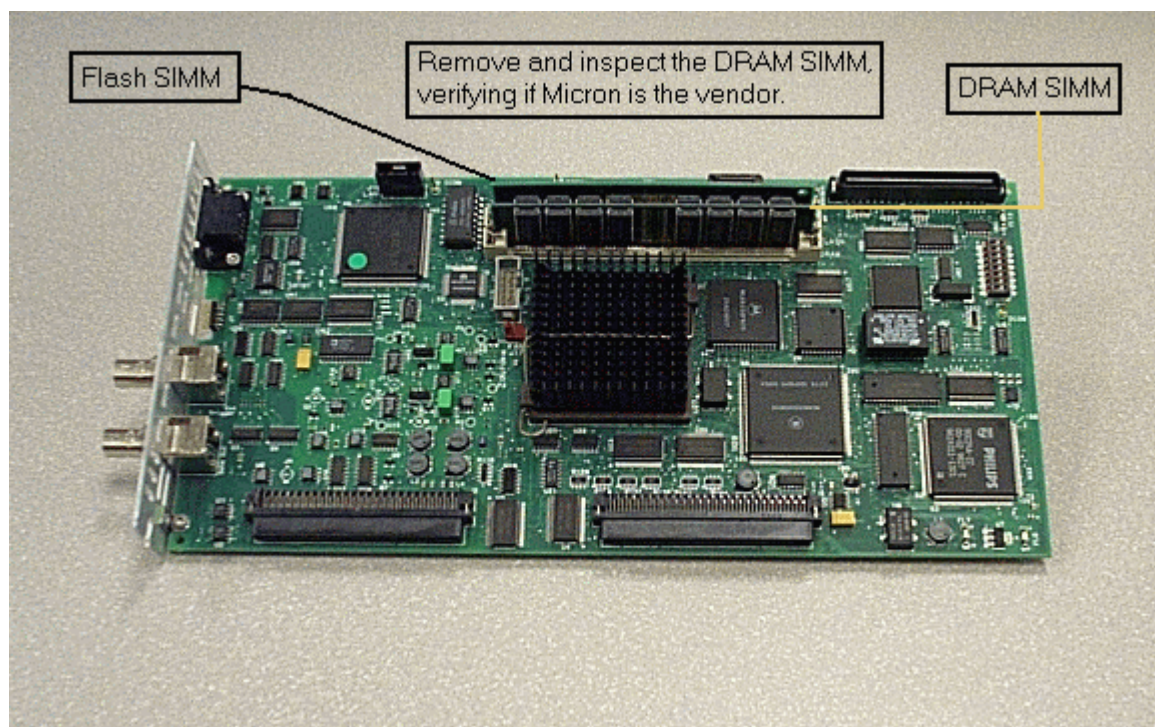
DRAM SIMMS using Micron parts can cause the instrument to lock-up and possibly white screen. This problem will only occur on instruments within the specified serial number range that have option B72, expanded memory. Micron has been removed from Agilent Technologies approved supplier list.

Remove the A4, CPU assembly from the instrument and pull out the DRAM SIMM pictured below. Additional information about removing the CPU assembly from the instrument can be found in the ESA or EMC Service Guide under chapter heading, "Replacing Assemblies". Inspect for Micron parts. If there is an "M" with a circle indicating the Micron parts, the SIMM should be replaced. All other component manufacturers are fine.
