**E4404B-10**

**S E R V I C E N O T E**

**E4404B 9 kHz to 6.7 GHz ESA Spectrum Analyzer**

**Replace Micron DRAM SIMMS from the A4, CPU assembly that can cause intermittent lock-up issues on instruments having option B72 only.**

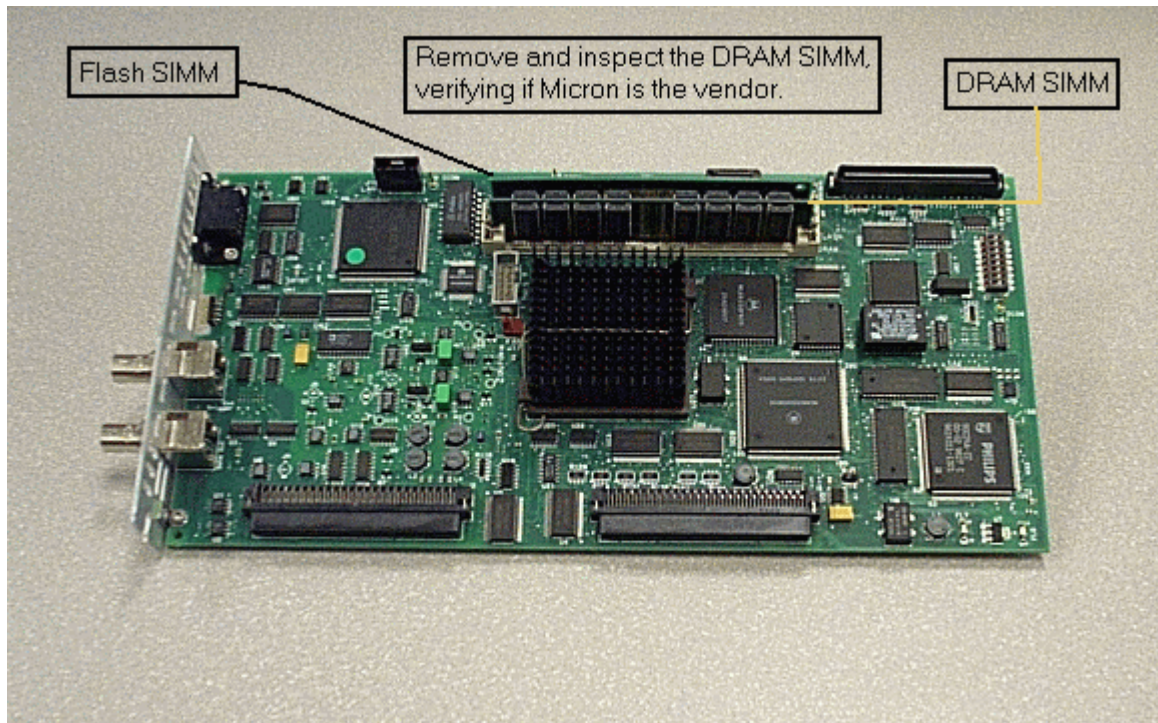
DRAM SIMMS using Micron parts can cause the instrument to lock-up and possibly white screen. This problem will only occur on instruments within the specified serial number range that have option B72, expanded memory. Micron has been removed from Agilent Technologies approved supplier list.

Remove the A4, CPU assembly from the instrument and pull out the DRAM SIMM pictured below. Additional information about removing the CPU assembly from the instrument can be found in the ESA or EMC Service Guide under chapter heading, "Replacing Assemblies". Inspect for Micron parts. If there is an "M" with a circle indicating the Micron parts, the SIMM should be replaced. All other component manufacturers are fine.
