E4405B-18

<u>SERVICE NOTE</u>

E4405B ESA Series Spectrum Analyzers

An error message occurs during the 3 GHz RF Assembly Adjustment portion of the TME LO Amplitude Adjustment test on the instruments which have certain vintages of the ESA RF assembly.

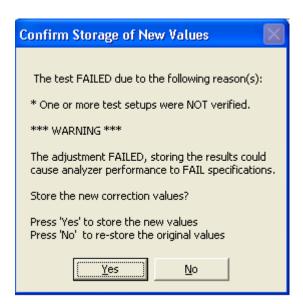
After all the portions except the 3 GHz RF Assembly LO Adjustment of the LO Amplitude Adjustment test are run, when you click on "Finish" Test, the following message appears on the screen.

This error message occurs because the 3 GHz RF Assembly Adjustment portion of the LO Amplitude Adjustment test was not performed. Click "Yes" to store the new values. After you click yes, the following message appears on the PC screen:

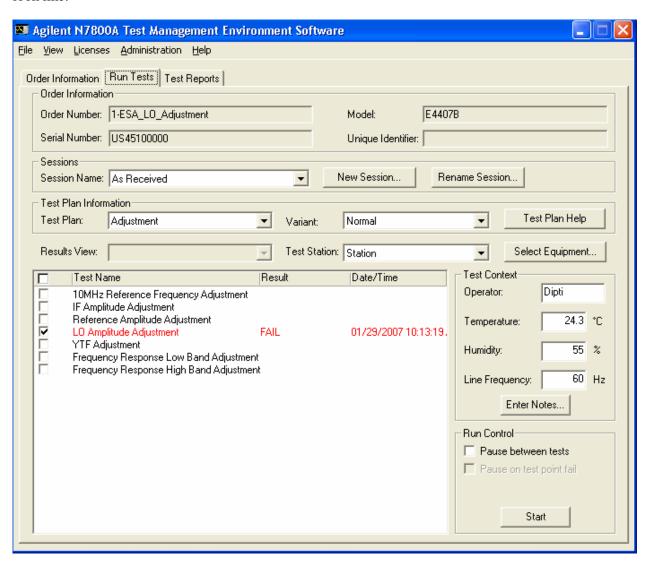
Click on "Run Next test" or just wait for 5 seconds, depending on the tests you are running. After 5 seconds or after all the other adjustment tests are performed, here is what the adjustment test result will look like:

The LO Amplitude adjustment test result appears as Fail because the 3 GHz RF Assembly Adjustment portion of the LO Amplitude Adjustment test was not performed. Ignore the fail message and continue with your tests.

The software engineering team is working on getting the TME software updated to remedy this situation. The updated version will be ready by July 2007. Check your TME software for updates during that time frame.
