E4407B-18

S E R V I C E N O T E

E4407B ESA Series Spectrum Analyzers

An error message occurs during the 3 GHz RF Assembly Adjustment portion of the TME LO Amplitude Adjustment test on the instruments which have certain vintages of the ESA RF assembly.

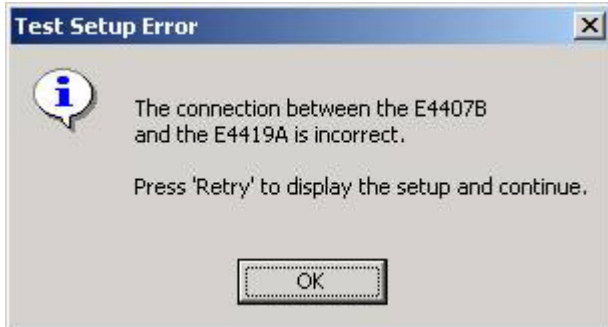
If the ESA being adjusted has a 50 ohm, 3 GHz input part number of E4403-60100 or E4403-60107, the 3 GHz RF Assembly Adjustment portion of the LO Amplitude Adjustment test will fail. The error message on the PC looks like:

The failure is occurring because a DAC was recently removed from the RF assembly board and replaced with a fixed gain amplifier.

Before doing the LO Amplitude adjustment, press [System], {More 1 of 3}, {Show Hardware} on your analyzer. Look for “50 ohm 3 GHz Input” assembly name. If the part number listed is E4403-60100 or E4403-60107, skip the 3 GHz RF Assembly LO Adjustment portion under the LO Amplitude Adjustment test. Perform all the other adjustments under the LO Amplitude Adjustment except this one.

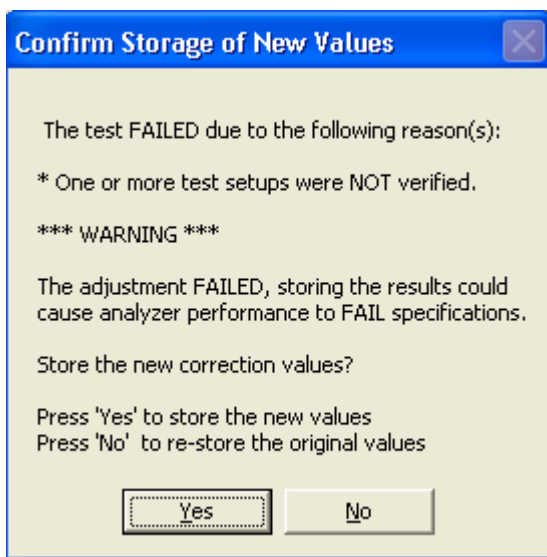
After all the portions except the 3 GHz RF Assembly LO Adjustment of the LO Amplitude Adjustment test are run, when you click on “Finish” Test, the following message appears on the screen.

This error message occurs because the 3 GHz RF Assembly Adjustment portion of the LO Amplitude Adjustment test was not performed. Click “Yes” to store the new values. After you click yes, the following message appears on the PC screen:
