S E R V I C E N O T E

E4401B, E4402B, E4403B, E4404B, E4405B, E4407B, E4408B, and E4411B ESA Spectrum Analyzer family. Also E7401A, E7402A, E7403A, E7404A, and E7405A EMC Pre-Compliance Analyzers.

Intermittent screen "flicker" due to a cold solder joint

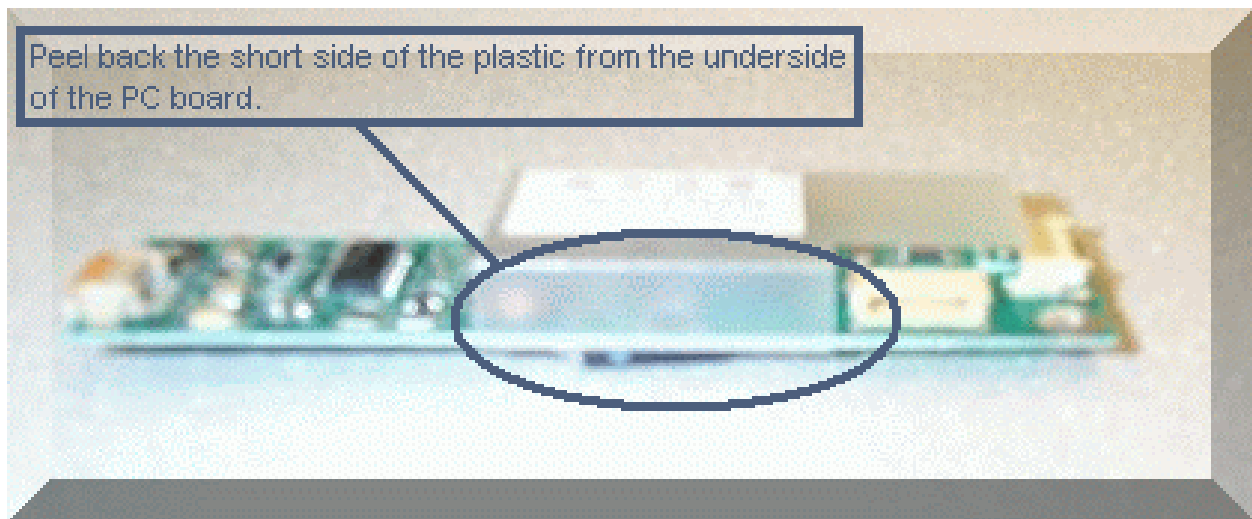
Figure 1

Instruments within the above serial range can experience an intermittent screen "flicker" due to a cold solder joint on pin 7 of the transformer on the backlight inverter board. The backlight inverter board attaches to the front panel interface board (A1A1) on the analyzer. The attached figures below in the Solution/Action section can be referenced on the procedure to use to correct for this problem.

- 1) Peel back the plastic shield on the backlight inverter board. See Figure 1.

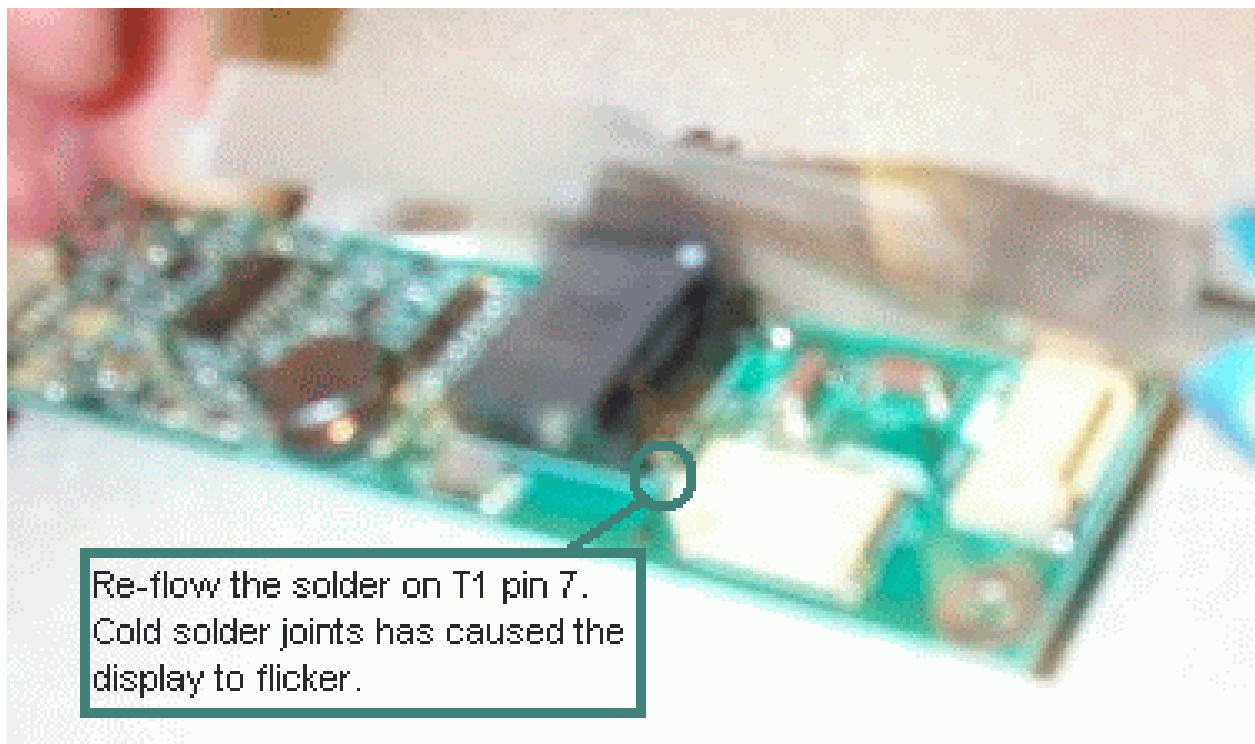
Figure 3

The backlight inverter board and LCD display are procured together as an assembly from NEC. Manufacturing has troubleshot screen flicker issues to poor solder quality on pin 7 of the transformer on the backlight inverter board. NEC has been notified and an inspection process implemented in manufacturing to cure this problem.

3) Re-solder pin 7 of the transformer on the backlight inverter board. See Figure 3.
