S E R V I C E N O T E

**E4401B, E4402B, E4403B, E4404B, E4405B, E4407B, E4408B, and E4411B ESA Spectrum Analyzer family. Also E7401A, E7402A, E7403A, E7404A, and E7405A EMC Pre-Compliance Analyzers.**

**Intermittent screen "flicker" due to a cold solder joint**

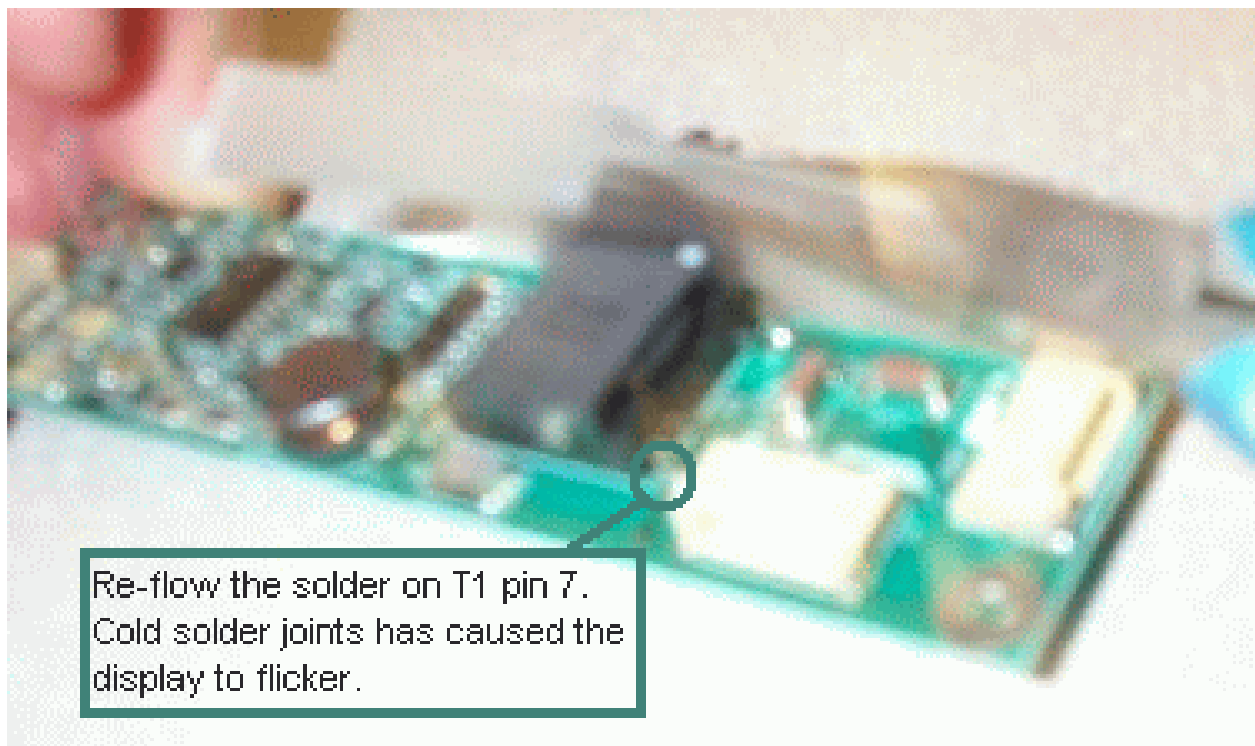
**Figure 3**

Instruments within the above serial range can experience an intermittent screen "flicker" due to a cold solder joint on pin 7 of the transformer on the backlight inverter board. The backlight inverter board attaches to the front panel interface board (A1A1) on the analyzer. The attached figures below in the Solution/Action section can be referenced on the procedure to use to correct for this problem.

The backlight inverter board and LCD display are procured together as an assembly from NEC. Manufacturing has troubleshot screen flicker issues to poor solder quality on pin 7 of the transformer on the backlight inverter board. NEC has been notified and an inspection process implemented in manufacturing to cure this problem.

3) Re-solder pin 7 of the transformer on the backlight inverter board. See Figure 3.
