**E7401A-06**

# S E R V I C E N O T E

## E7401A 1.5 GHz EMC Analyzer

**Firmware Update to Fix High Noise Floor on the Analyzer Screen.**

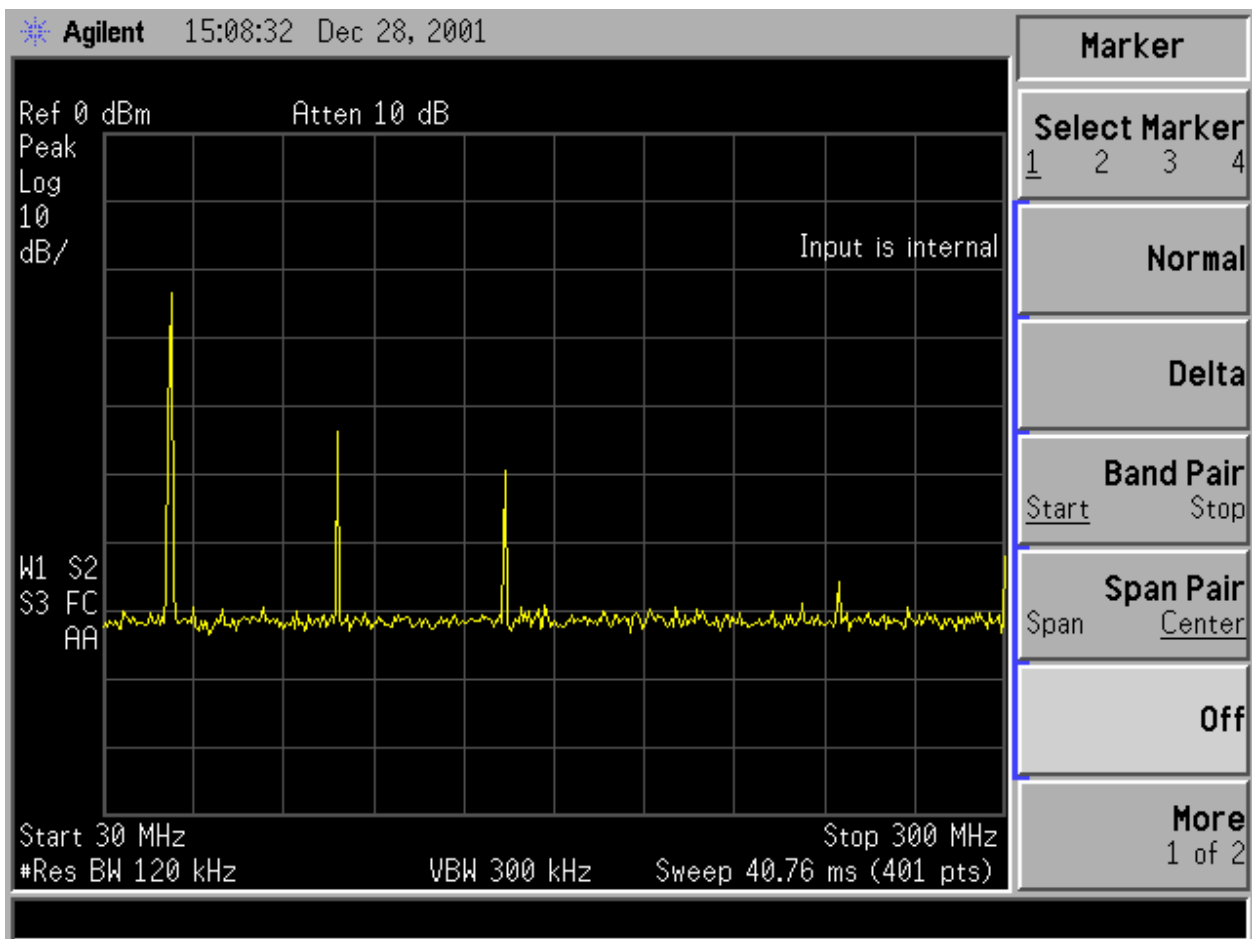
You should see the Alignment signal (50 MHz) and harmonics on screen as shown below.

Press System, More 1 of 3, More 2 of 3, Service –2010 Enter, Service, Align, LO. If the instrument is affected, then either the Align signal & harmonics will disappear or they will move around quickly and erratically on screen. If this occurs, contact the customer and verify the latest shipping version of ESA firmware can be upgraded in their instrument. If the instrument has option B72, Expanded Memory the instrument can be upgraded to the latest and greatest firmware. Otherwise, A.07.05 is the highest revision allowed. If the customer cannot accept the new firmware, contact Agilent Customer Support At PGU, SA-SUPPORT or call us in the U.S. A. at (707) 577-6801.
