**E7404A-06**

**S E R V I C E N O T E**

**E7404A 9 kHz to 13.2 GHz EMC Analyzer**

**Replace Micron DRAM SIMMS from the A4, CPU assembly that can cause intermittent lock-up issues on instruments having option B72 only.**

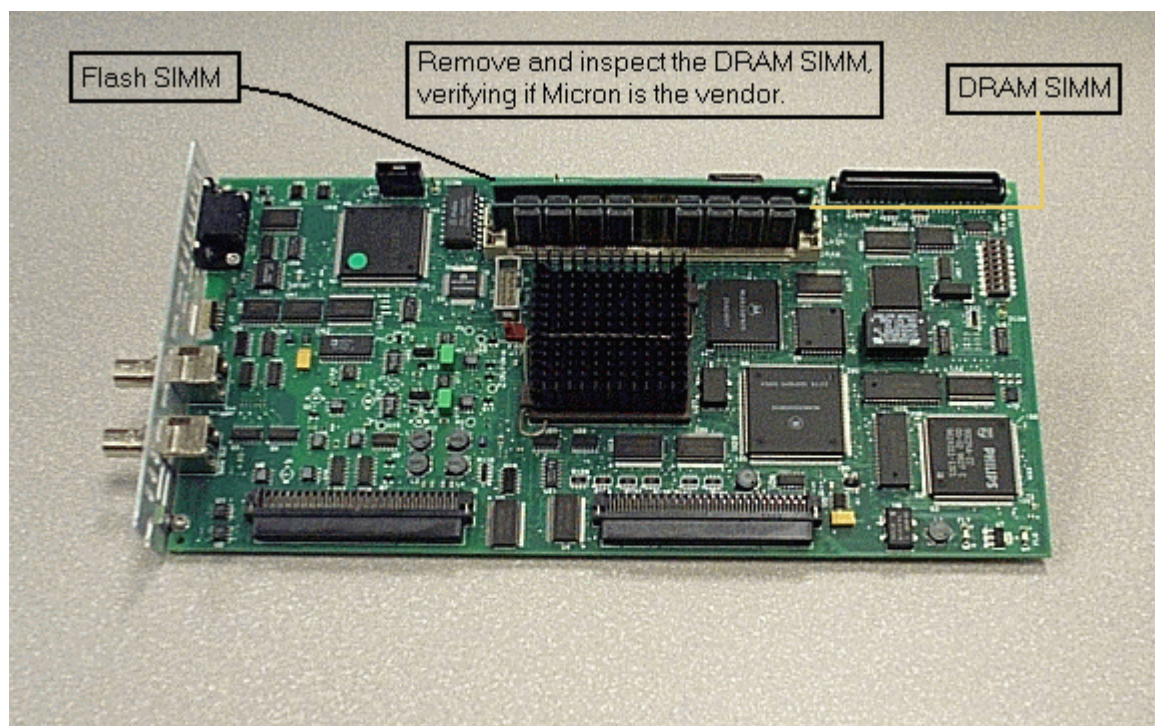
DRAM SIMMS using Micron parts can cause the instrument to lock-up and possibly white screen. This problem will only occur on instruments within the specified serial number range that have option B72, expanded memory. Micron has been removed from Agilent Technologies approved supplier list.

Remove the A4, CPU assembly from the instrument and pull out the DRAM SIMM pictured below. Additional information about removing the CPU assembly from the instrument can be found in the ESA or EMC Service Guide under chapter heading, "Replacing Assemblies". Inspect for Micron parts. If there is an "M" with a circle indicating the Micron parts, the SIMM should be replaced. All other component manufacturers are fine.
