377	′17B-	-10
S	Е	R	V	I	С	Е	Ν	0	Т	Е
377	717B PI	)H/SD	H/Jitter	Test	t Set		SUPERSEDES	S: NON	E	
Ser	ial Numbo	ers: N/A	A							
Opt	tions: Al	11								
Bui	ld Status:	2:23 to	2:69							
Ins	trument	: Fails t	to Downl	oad l	Firmware	e via∣	Floppy disk			
To	be Perfor	med by:	Qualified	Servic	ce Personne	el				
Par	ts Requir	ed:								
Des	cription	Р	art Numbe	er	Quantit	y B	uild Status Affec	eted		
	eened disk e Kit	- 3	7717-60190	)	1		2:23 to 2:40 (inc	c)		
	lated Wire	e			0.25	Metre	2:23 to 2:69(inc	)		
Situ	ation									
with		atus Nurr	nber in the a				are via disks on 3 nent Build Status			
									Continue	ed
							DATE: March	1997

## **MODIFICATION RECOMMENDED**

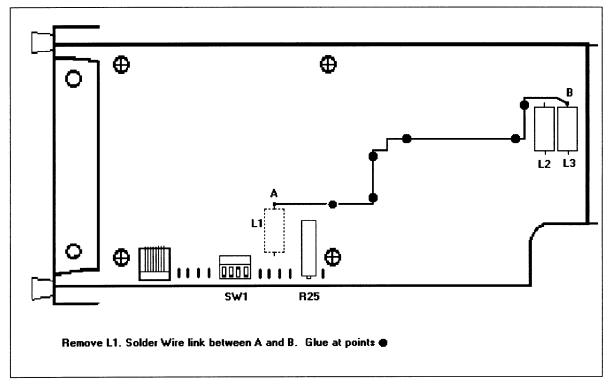
Figure 1 - Showing the Wire-Link modification to the Processor Board

These problems are due to insufficient RFI screening on the new version of disk drive introduced at BS2:23. Improved screening was introduced into production units at BS2.41.

A wire-link modification to the processor PCB to improve the stability of the disk-drive supply voltage should also be done on these units. This modification was introduced at BS 2:69.

If any 37717B unit with Build Status between 2:23 and 2:69 (inclusive) is encountered, carry out the wire-link modification to the processor PCB as described below.

#### Adding the Wire-Link (See Figure 1)
