S E R V I C E N O T E

OmniBER 37718 / 37719 Comms Performance Analyzer

Build Code Status 3:30 and below

The following modification is recommended to eliminate potential overheating and premature failure of DS_n DS1 Drop (Demux) Port driver.

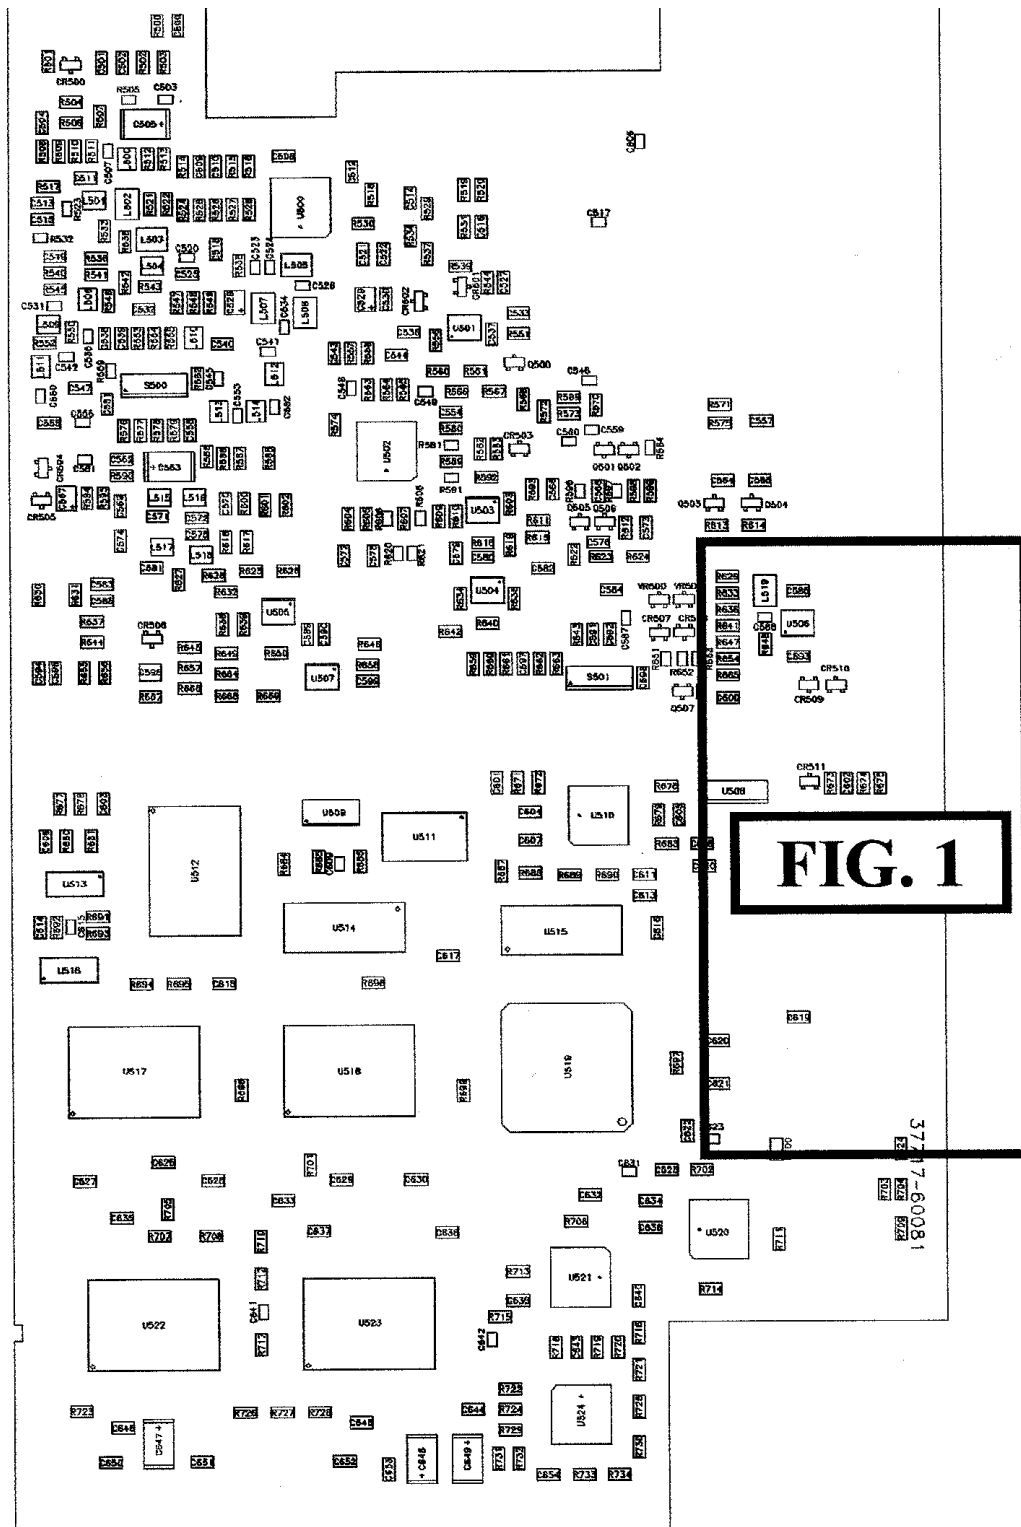
Figure 1. Location of Components.

If failure of the DS1 Drop (Demux) Port is already evident, the U506 will also need to be replaced, before implementing this modification.

2. Note: Only perform this step if DSn Drop Port is defective. Remove/replace U505 (PN 1820-8942) taking note of orientation.
3. Solder a 10k ohm resistor Ra (0699-1391) to rh pin of TP8.
4. Solder a 10k ohm resistor Rb (0699-1391) to rh pin of TP8.
5. Add a wire link from vacant end of Ra to U506 pin 1 using insulated wire (see Figures 1 and 2).
6. Add a wire link from vacant end of Rb to U506 pin 7 using insulated wire (see Figures 1 and 2).
