37718A-04

S E R V I C E N O T E

**37718A OmniBER 718 Communications Performance
Analyzer**

Optical Receiver Damage due to excessive Optical Overload/Transient

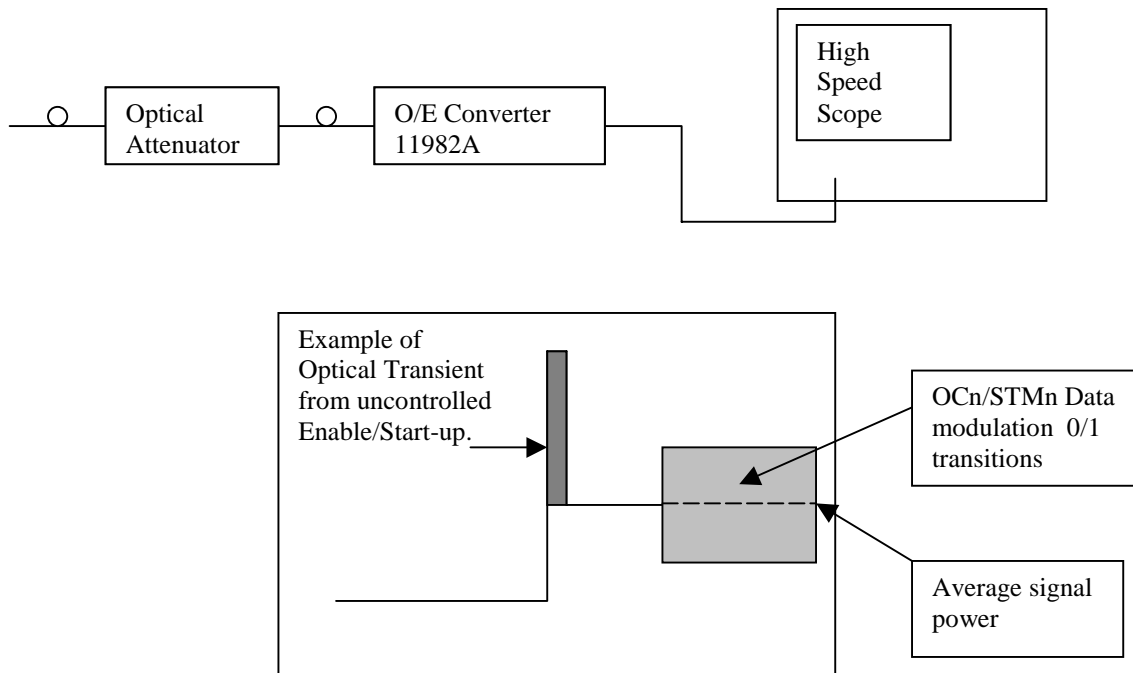
Sample set-up

Optical Attenuator - Agilent 8156A
 O/E Converter - Agilent 11982A
 Oscilloscope - Agilent 54845A

Note scope must be capable of single-shot trigger from input signal.

Contact the customer and check the conditions under which the Optical Receiver was damaged and alert the user to appropriate operating signal levels and attenuation. Request that the customer check procedures and application for excessive optical power and unexpected optical transients when laser is being enabled. This can be done using an optical attenuator, O/E converter and an oscilloscope to capture and analyze the power-on/enable transient of the laser.

If excessive laser enable transients are observed then there is a need to ensure that Test Sets are protected by appropriate additional attenuation and the customer will of course want to investigate the reasons for any unexpected excessive transient from their equipment.
