37719A-02

S E R V I C E N O T E

**37719A OmniBER 718 Communications Performance
Analyzer**

Optical Receiver Damage due to excessive Optical Overload/Transient

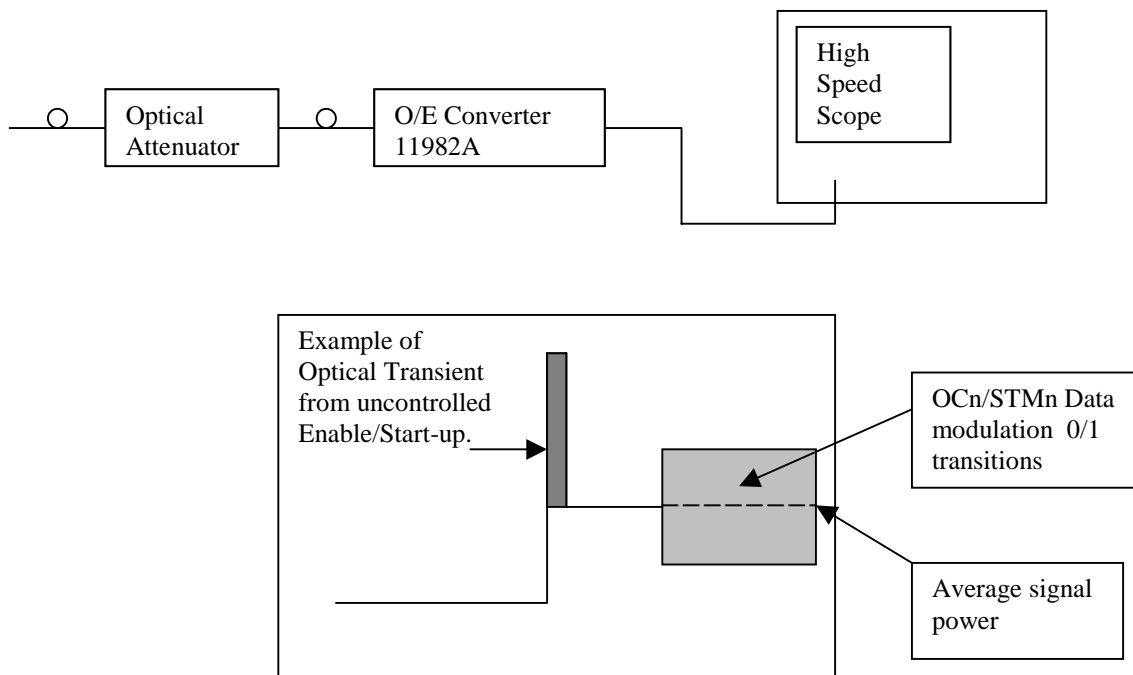
Sample set-up

Optical Attenuator - Agilent 8156A
 O/E Converter - Agilent 11982A
 Oscilloscope - Agilent 54845A

Note scope must be capable of single-shot trigger from input signal.

If excessive laser enable transients are observed then there is a need to ensure that Test Sets are protected by appropriate additional attenuation and the customer will of course want to investigate the reasons for any unexpected excessive transient from their equipment.
