S E R V I C E N O T E

OmniBER 37718 / 37719 Comms Performance Analyzer

DATE: August 2000

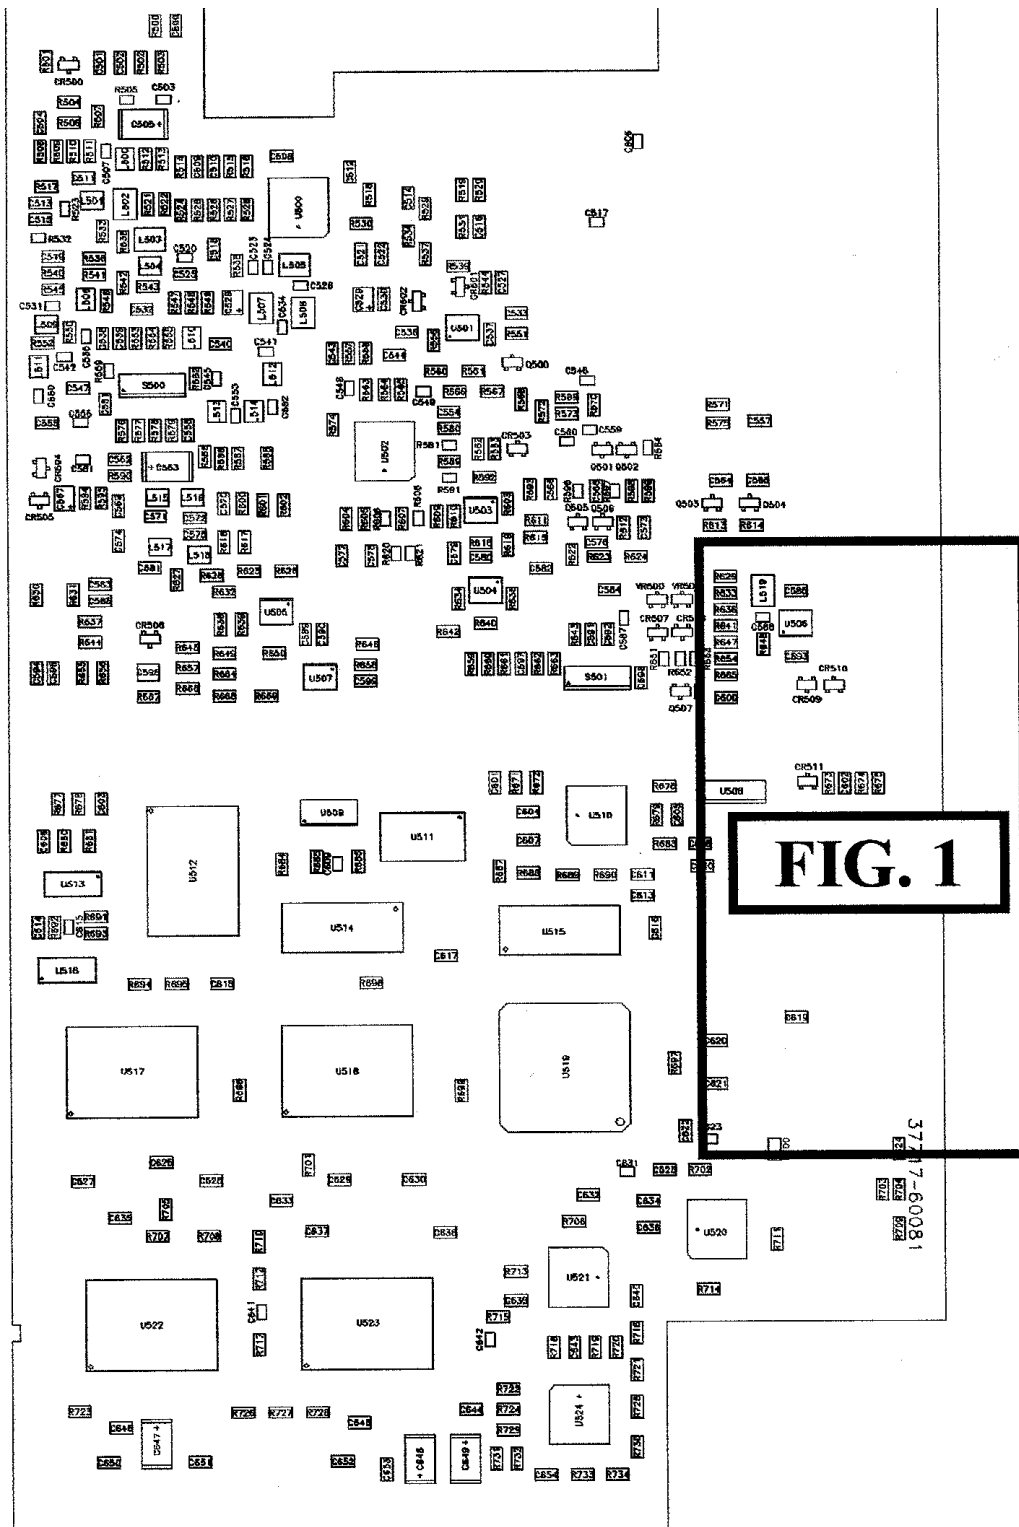
Figure 1. Location of Components.

The following modification is recommended to eliminate potential overheating and premature failure of DS_n DS1 Drop (Demux) Port driver.

2. Note: Only perform this step if DS_n Drop Port is defective. Remove/replace U505 (PN 1820-8942) taking note of orientation.
3. Solder a 10k ohm resistor Ra (0699-1391) to rh pin of TP8.
4. Solder a 10k ohm resistor Rb (0699-1391) to rh pin of TP8.
5. Add a wire link from vacant end of Ra to U506 pin 1 using insulated wire (see Figures 1 and 2).
6. Add a wire link from vacant end of Rb to U506 pin 7 using insulated wire (see Figures 1 and 2).
