S E R V I C E N O T E

OmniBER 37718 / 37719 Comms Performance Analyzer

Build Code Status 3:30 and below

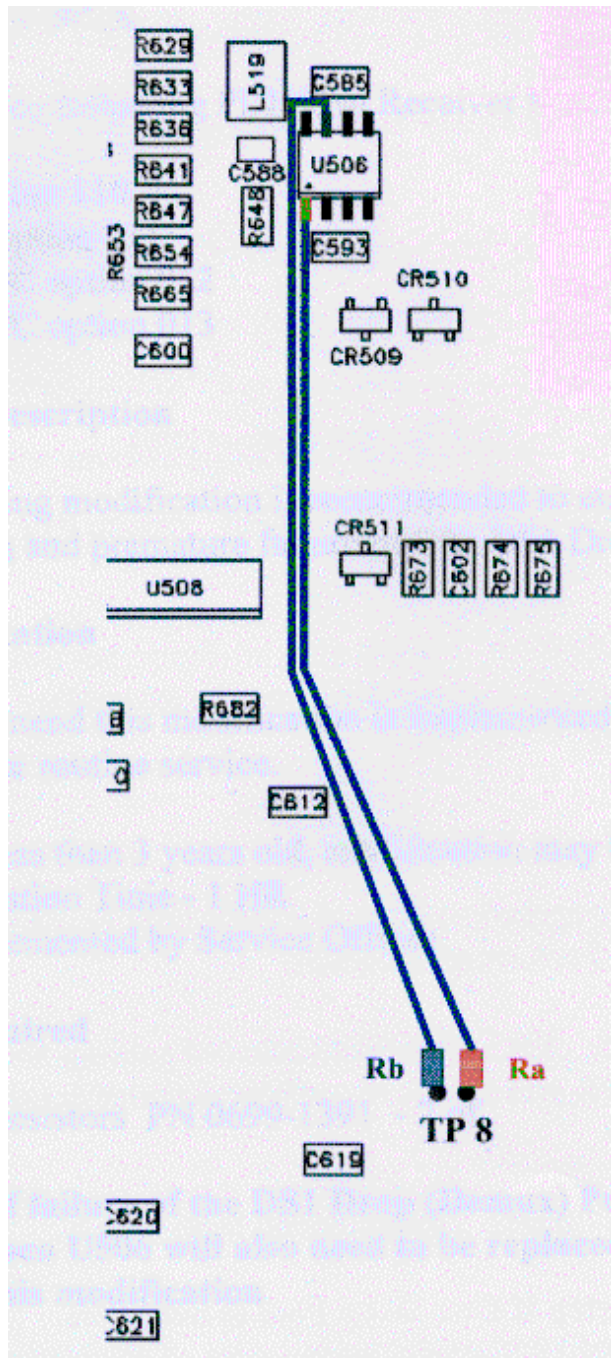
Figure 2. Position of Wire Link.

The following modification is recommended to eliminate potential overheating and premature failure of DS_n DS1 Drop (Demux) Port driver.

2. Note: Only perform this step if DS_n Drop Port is defective. Remove/replace U505 (PN 1820-8942) taking note of orientation.
3. Solder a 10k ohm resistor Ra (0699-1391) to rh pin of TP8.
4. Solder a 10k ohm resistor Rb (0699-1391) to rh pin of TP8.
5. Add a wire link from vacant end of Ra to U506 pin 1 using insulated wire (see Figures 1 and 2).
6. Add a wire link from vacant end of Rb to U506 pin 7 using insulated wire (see Figures 1 and 2).

7. Reinforce with epoxy.
8. Refit module and confirm correct operation of the Drop Port as in step 1.
9. Fit a label to the rear of the instrument to indicate that this Service Note has been implemented.
10. Record the modification on CSO for future records.
