S E R V I C E N O T E

8922A GSM RF Test Set

Recommended Removal of Hardware

DATE: 02 June 1994

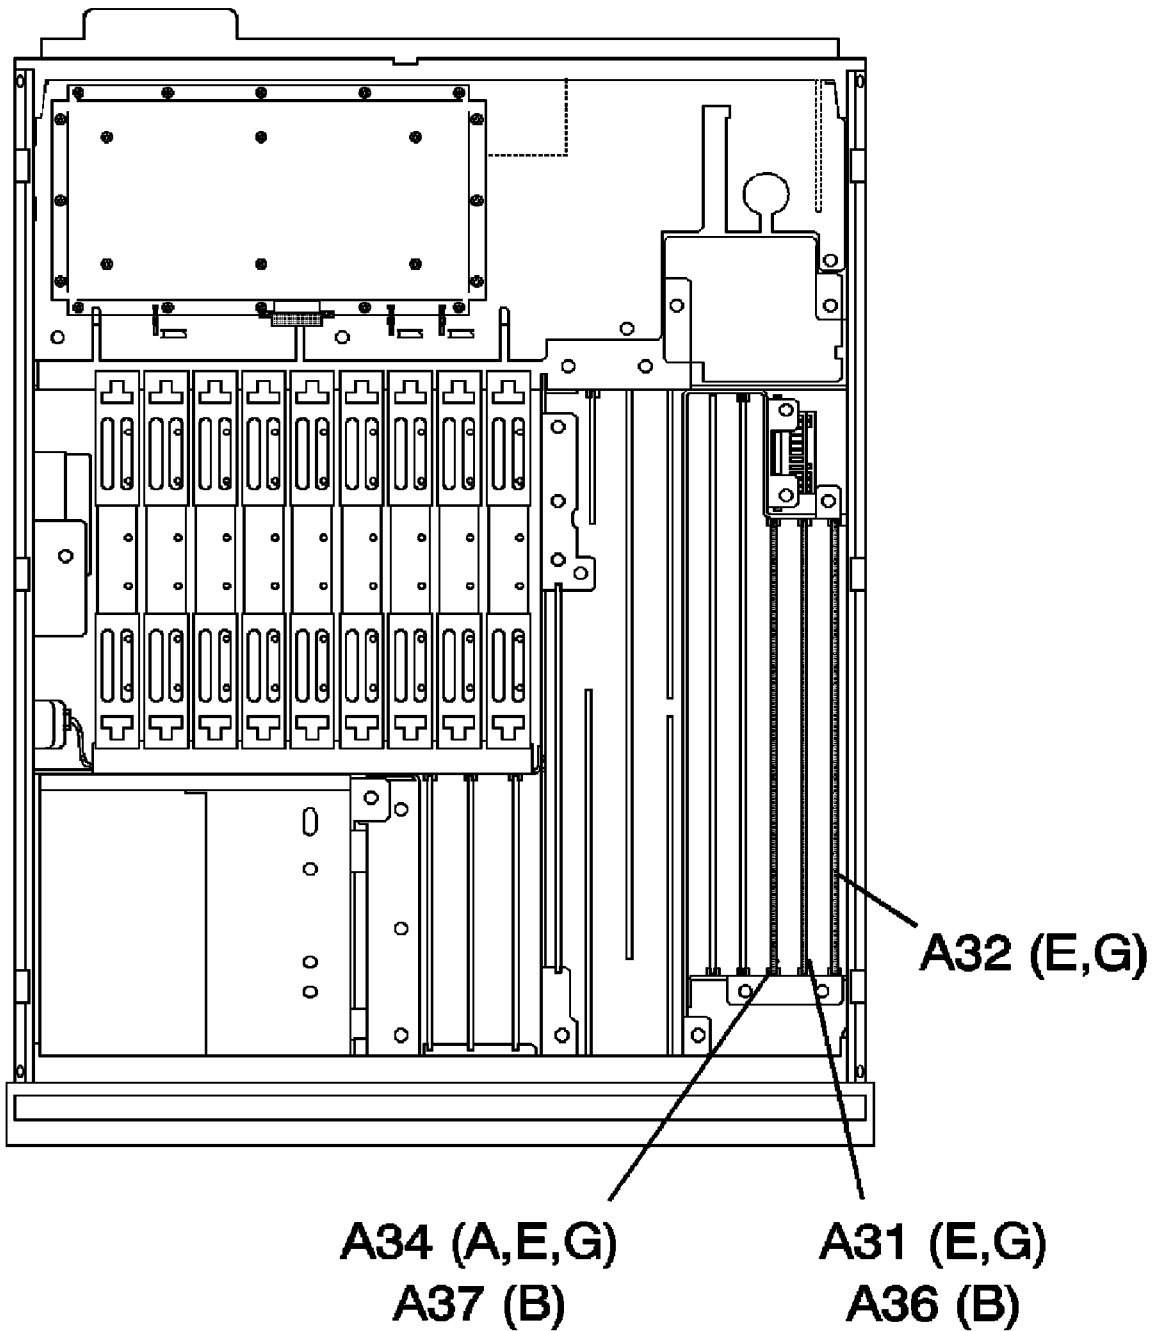
FIGURE 1
Top Internal View of HP 8922A/B/E/G

Instruments with serial numbers noted above may have internal hardware (screw and nut) which is improperly attached to the A34 RTI Bypass Assembly. Refer to Figure 1 for location of this assembly. The hardware can become separated from the assembly, contact other circuitry and may cause electrical damage.
