S E R V I C E N O T E

8922B GSM BS Test Set

Recommended Removal of Hardware

Page 2 Service Note 8922B-01

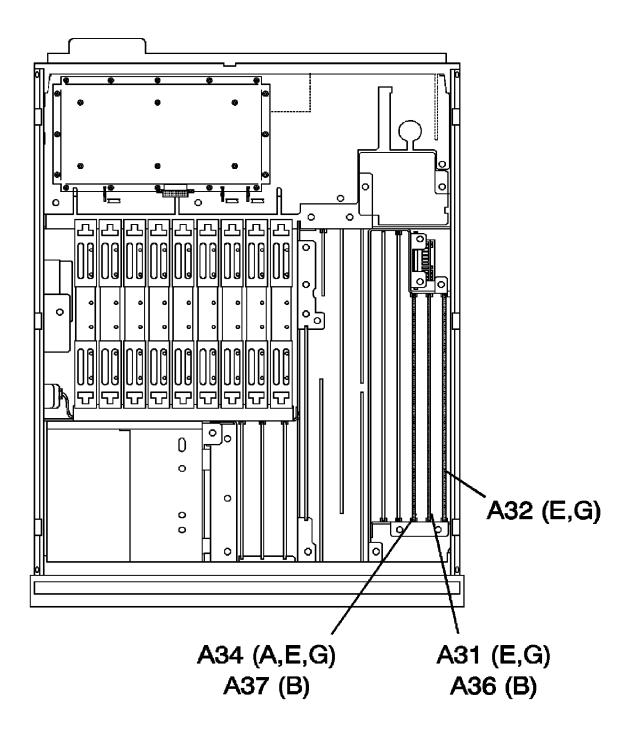
FIGURE 1
Top Internal View of HP 8922A/B/E/G

Instruments with serial numbers noted above may have internal hardware (screw and nut) which is improperly attached to the A36 FIFO GPIO and A37 Sequence Controller assemblies. Refer to Figure 1 for location of these assemblies. The hardware can become separated from the assembly, contact other circuitry and may cause electrical damage.
