8922G-01

Serial Numbers: 3050A00101 / 3343A00550

Recommended Removal of Hardware

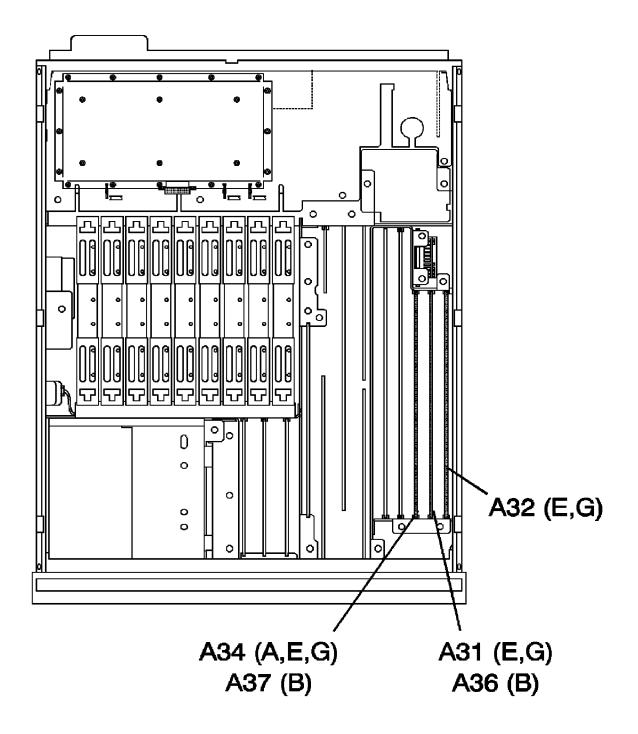
FIGURE 1 Top Internal View of HP 8922A/B/E/G

Instruments with serial numbers noted above may have internal hardware (screw and nut) which is improperly attached to the A31 GSM CODEC, A32 GSM Controller, and A34 GSM RTI assemblies. Refer to Figure 1 for location of these assemblies. The hardware can become separated from the assembly, contact other circuitry and may cause electrical damage.
