E7907A-01

S E R V I C E N O T E

E7907A 2 Port OC3 ATM/POS Router Tester Module

May 2, 2002

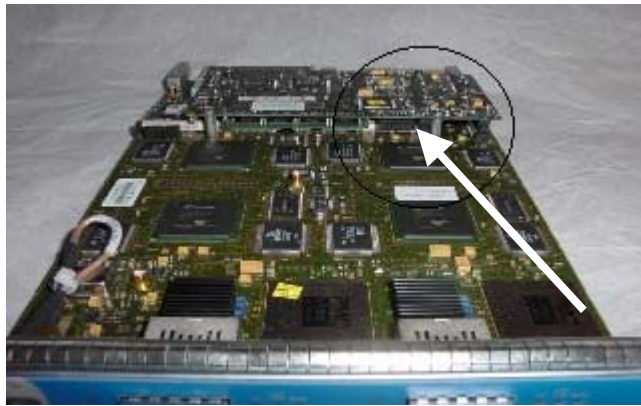
Figure 1: Position the card so that the jumper can be identified.

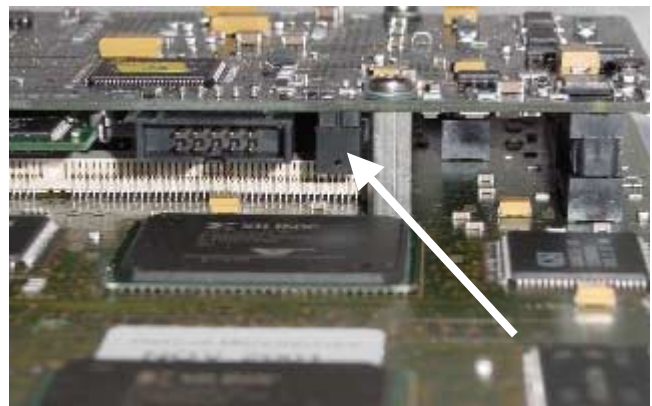
E7907A RouterTester modules were shipped with jumper P4 installed when this should have been permanently removed

The module will occasionally lock up or reboot at random times

Figure 2: Locate the jumper on the CPU card.

Permanently remove jumper P4 from the CPU card

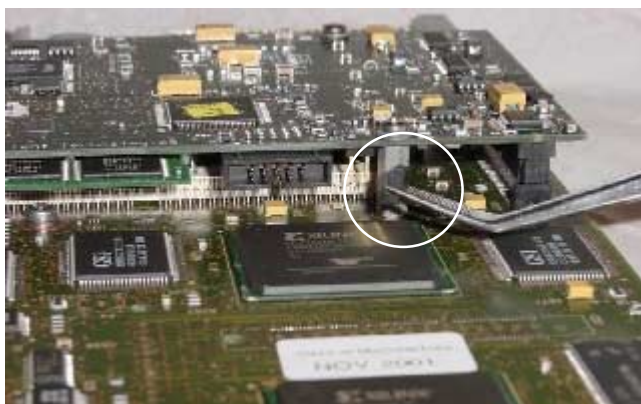
Figure 3: Remove the jumper.
